QC-7857

Lawn North 9.35km

2019 Inspection

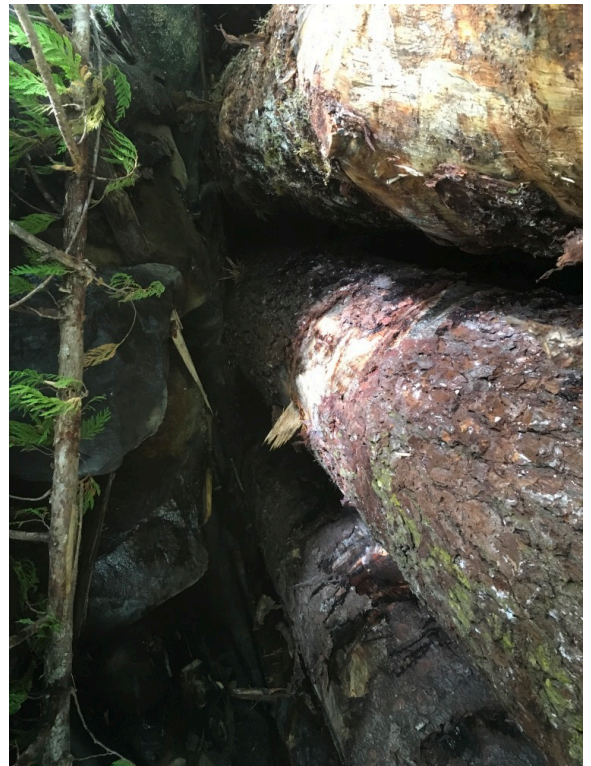
Stringers

Comments No stringers are peeled but they are all new within the last year or so. Ends of stringers appear to be gut lashed with old haulback cable. Browlogs are secured with drift pins at each end.
