QC-7906

QC\_LOO3000 1.3km

2019 Inspection

CBR iPad Offline Ver

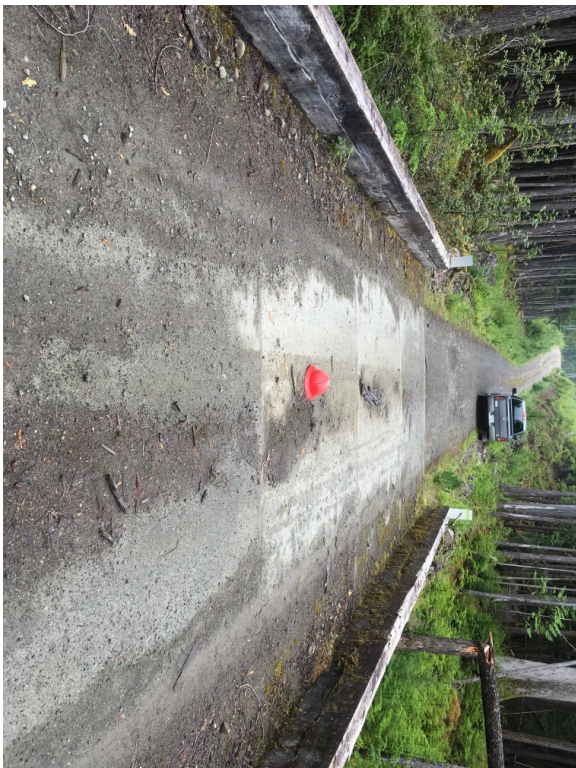
| Concrete Deck | Fair | Material accumulating on deck - clean debris off deck. Evidence of patching with grout to underside on deck on right bank abutment. |

| Item | Priority | Repair Description |
|---|---|---|
| 2 | Low | Clear accumulated debris off deck. |

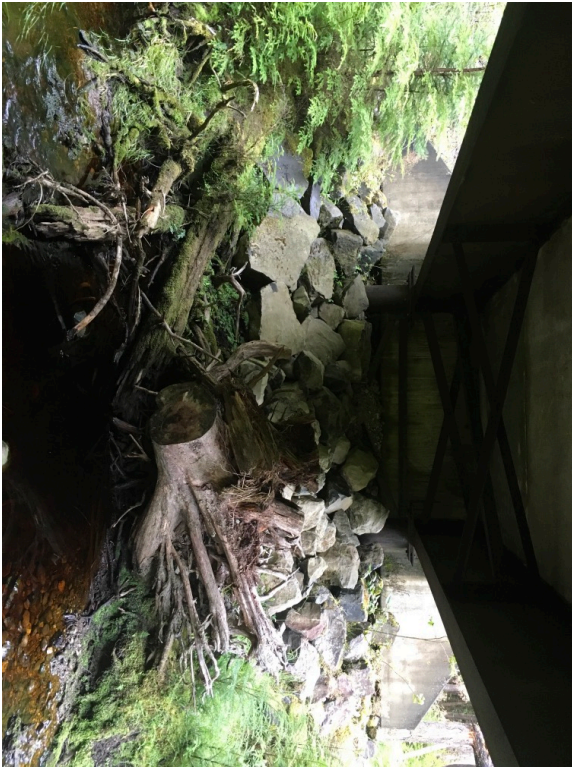
Left Bank Abutment when facing downstream

Minor deformation on left bank abutment, not significant.

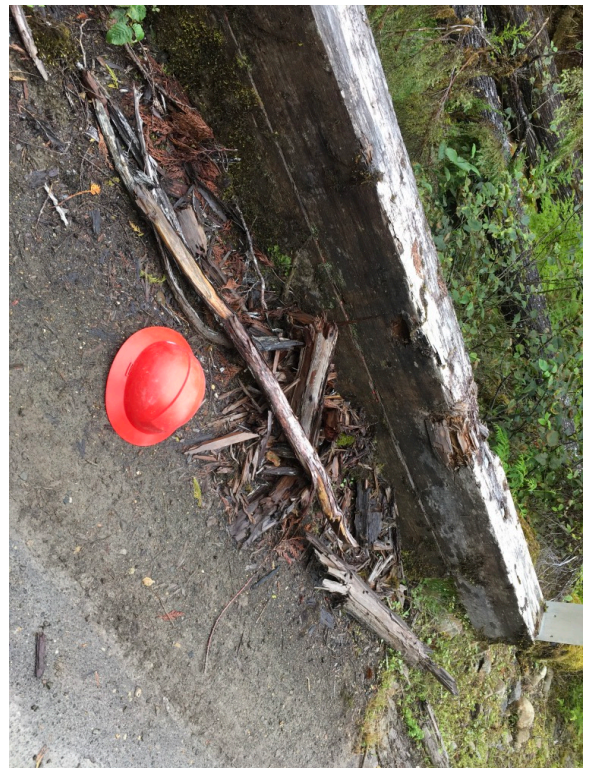
Guard Rail

Some rot in guardrails and minor scaling noted on steel components.

| Curb Rail/Blocks/Posts | Fair | Downstream right bank guardrail has been impacted. Still functional but should be replaced prior to industrial activity. Entire guardrail arrangement should be replaced in |

| Item | Priority | Repair Description |
|---|---|---|
| 1 | Medium | Replace guardrails and risers in 3 years or less, or patch replacement prior to next industrial activity. |
