**FINAL REPORT**

# **BAKER CREEK WATERSHED ASSESSMENT – PHASES 1 & 2**

## **Volume 1: Report**

**Project 040-42.02**

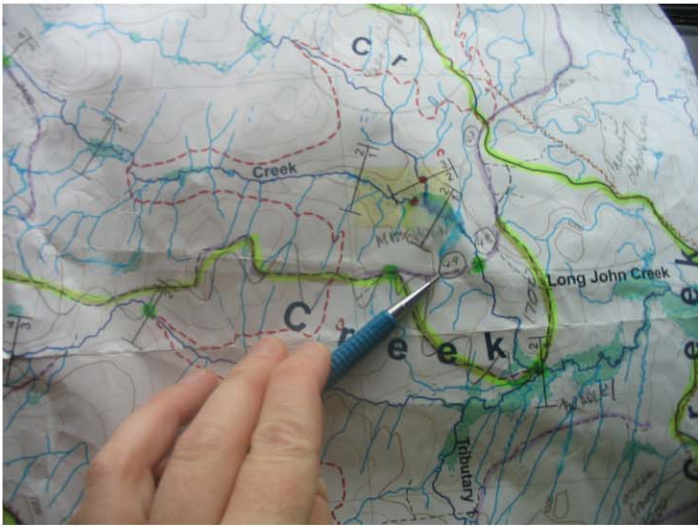
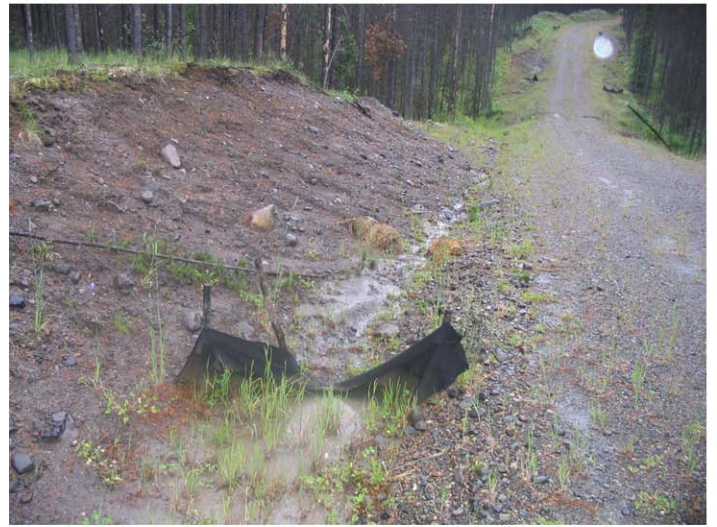
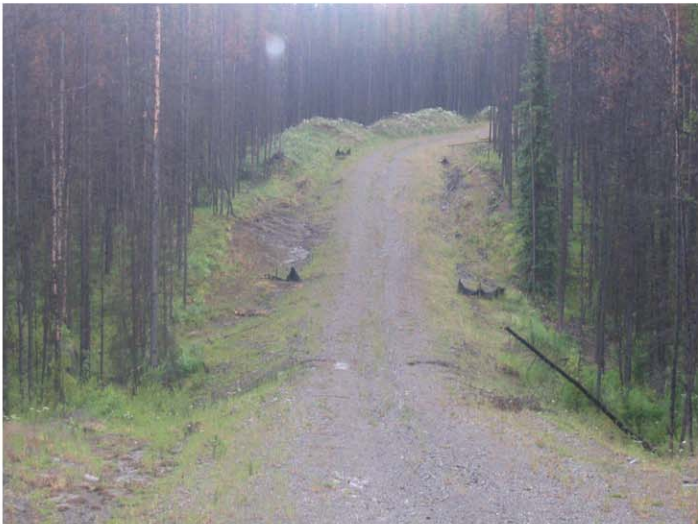
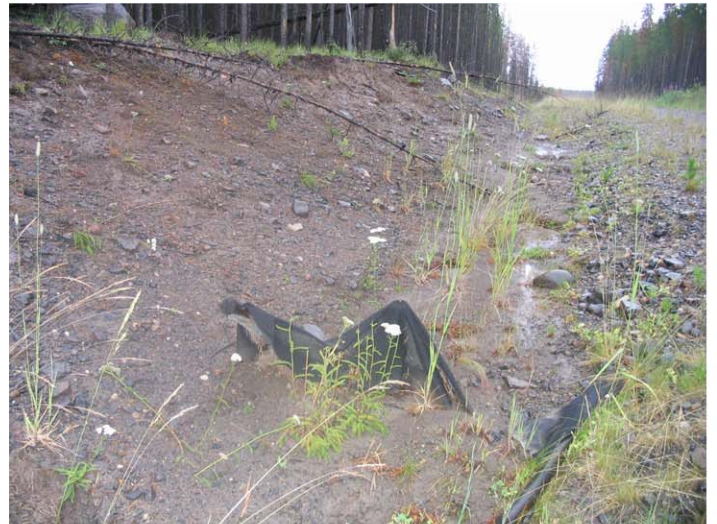
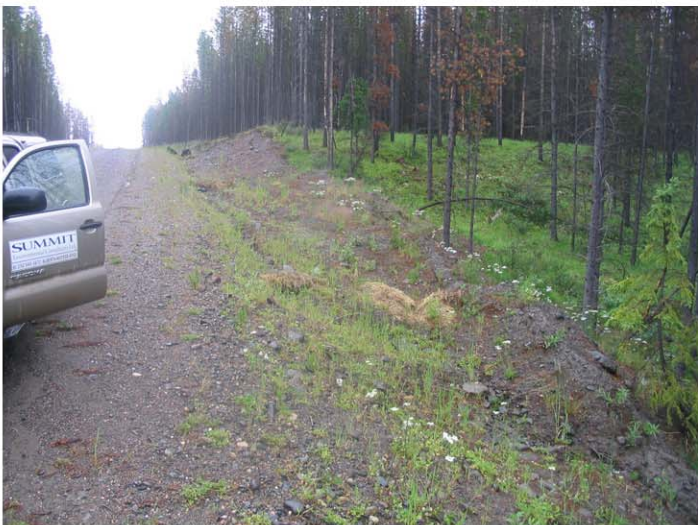
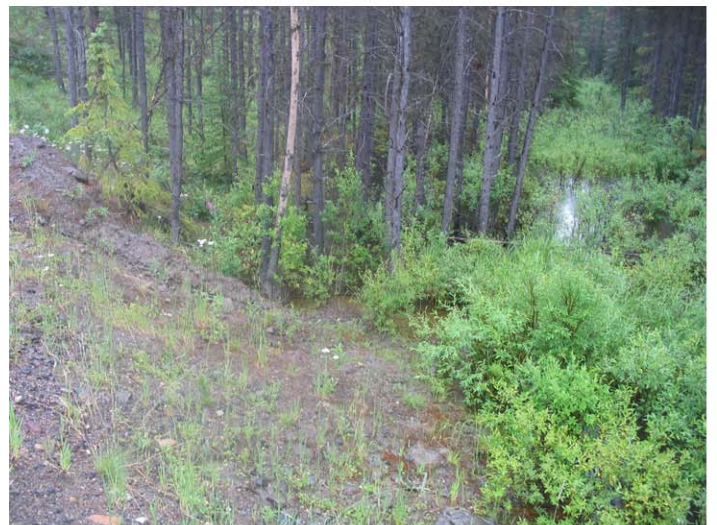
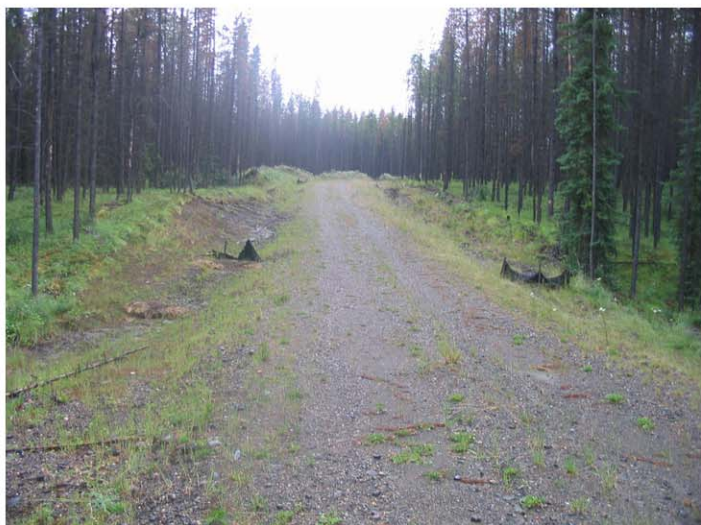
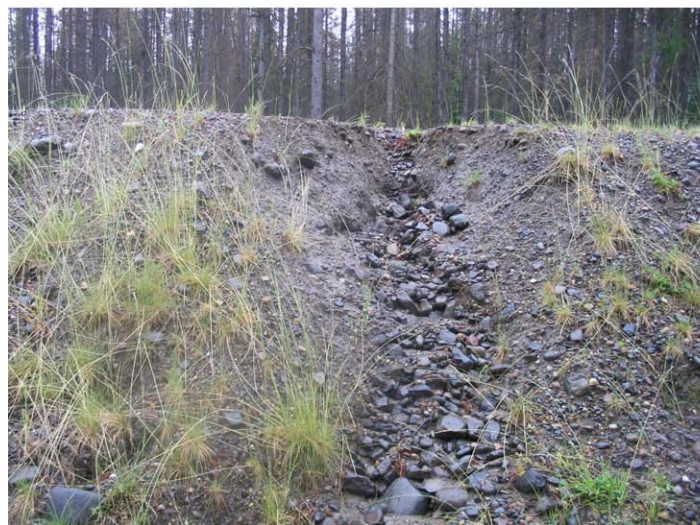
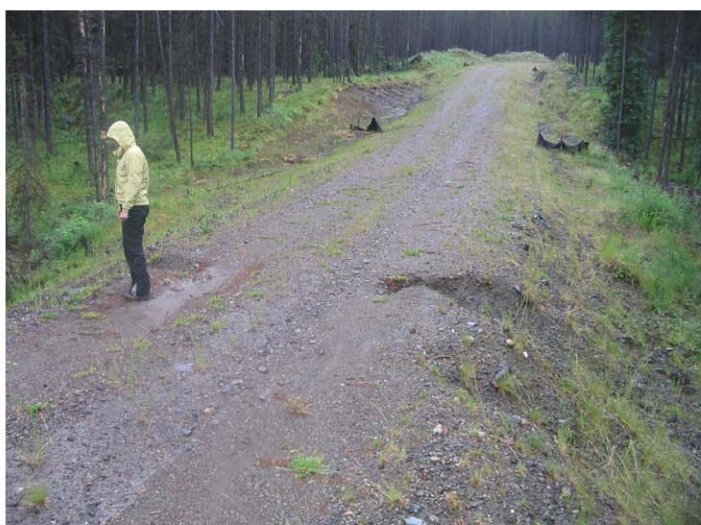
1. This high priority site is located on Tibbles Road at km 14+ near the mouth of Trapline Creek. The attached photographs (0406-0416) illustrate road erosion and excessive ditch erosion in all ditches (approximately 300 m in total) leading to an unnamed tributary of Trapline Creek. Sediment control measures (silt fences) are non-functioning and currently sediment is being delivered to the creek. Recommendations include clearing and armouring the ditches, installing rock check dams (removing the silt fences) in each ditch, regrading the road crown and embankment, and repairing the fill adjacent to the culvert.

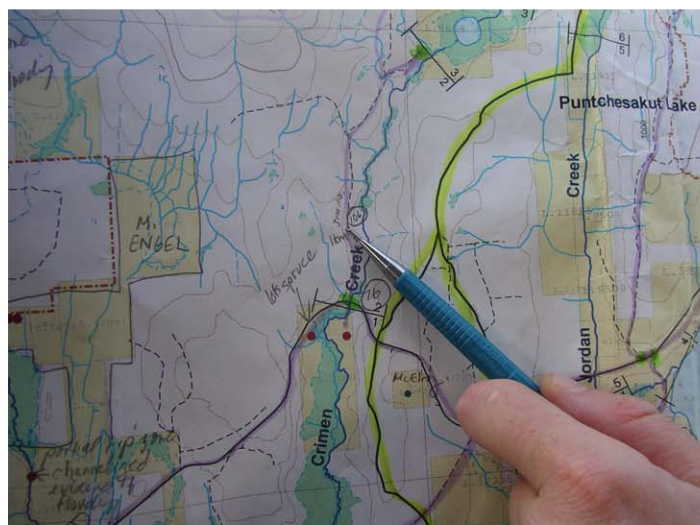
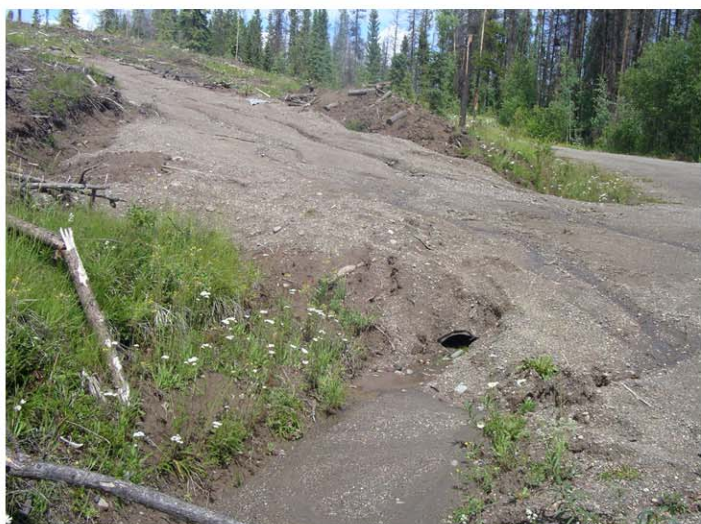
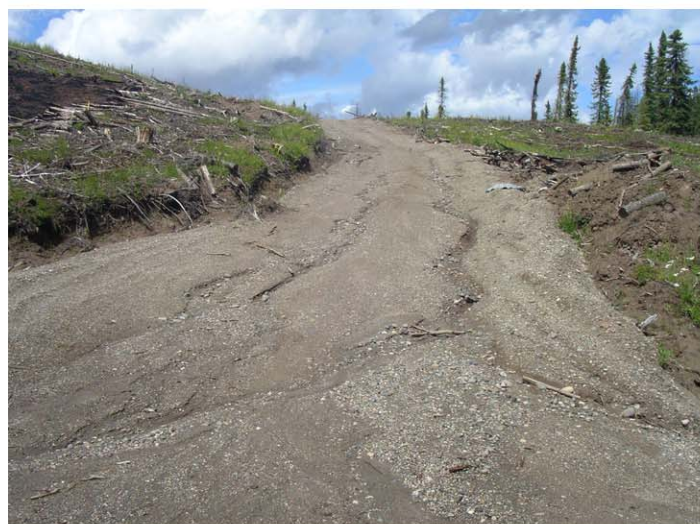
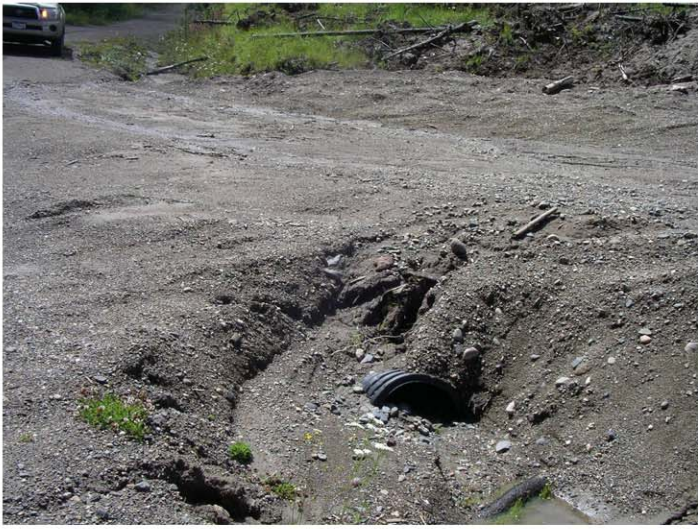
2. This moderate priority site is located at the entrance of a secondary cutblock road at km 1+ Crimen Creek (3100) Road. The attached photographs (2519-2522) illustrate the excessive surface erosion on the road and the non-functioning culvert. Recommendations include regrading the road, ditch and culvert clearing.
