BC Ministry of Forests, Lands, and Natural Resource Operations  
and Rural Development

POST-WILDFIRE NATURAL HAZARDS RISK ANALYSIS  
AKOKLI FIRE (N71686)

February 8, 2022

Report Number: 21.510.01.04.02

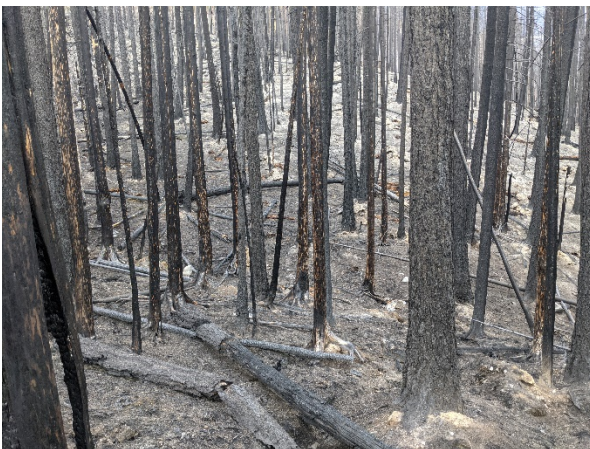
**Photo 9.** Example of high burn severity area - Akokli Drainage

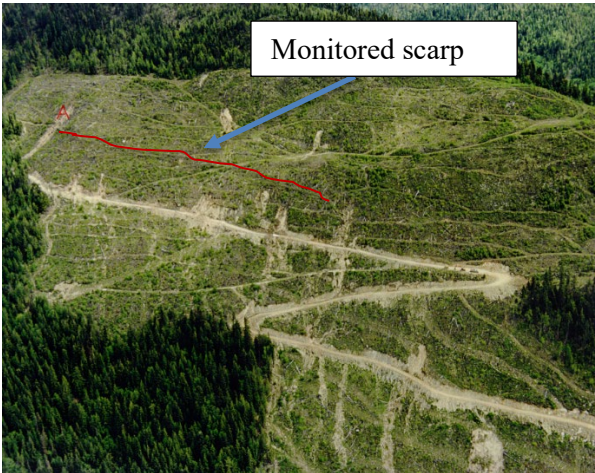
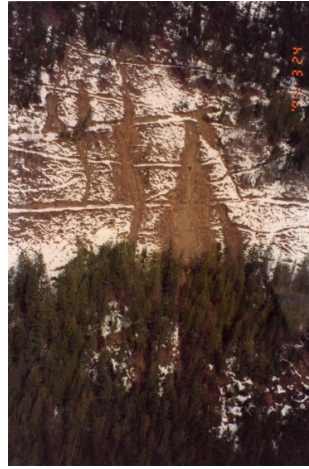
There is very little burned area above these landslide locations and there is little increase in hazard due to the wildfire. However, the area has historical instabilities and in fact a recent landslide (not wildfire related) was reviewed by one of the authors during the review of fire guards. The landslide is located below the McGregor FSR on the south side of the Charles Creek drainage (see Photos 22 and 23).

**Photo 20.** 1997 Charles Creek Landslides

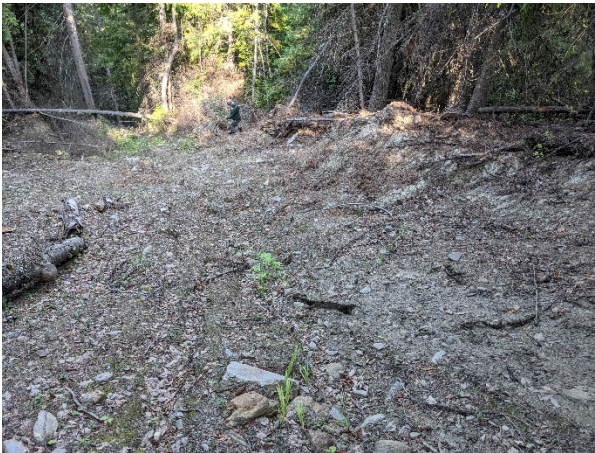
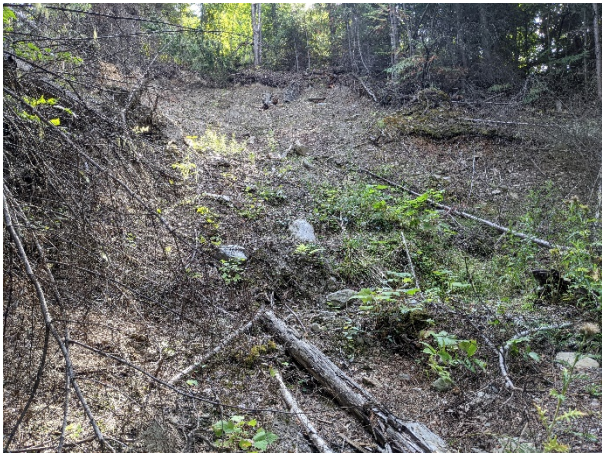
**Photo 22.** 5 km McGregor FSR landslide

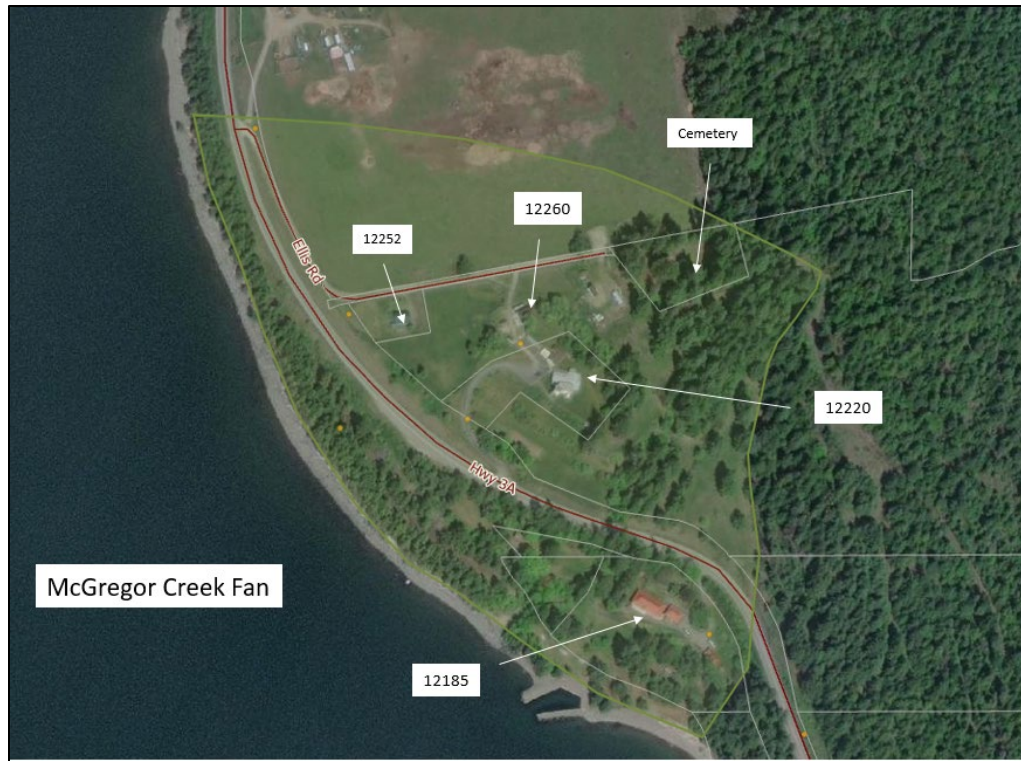
Figure 5 shows four houses and a cemetery on the fan. The creek channel is well incised from the apex of the fan to Hwy 3A (Photo 24). However, there is man-made obstruction in the gully at the apex of the fan in the form of a road crossing and water intake pond (Photo 25).

**Figure 5.** McGregor Creek fan elements at risk

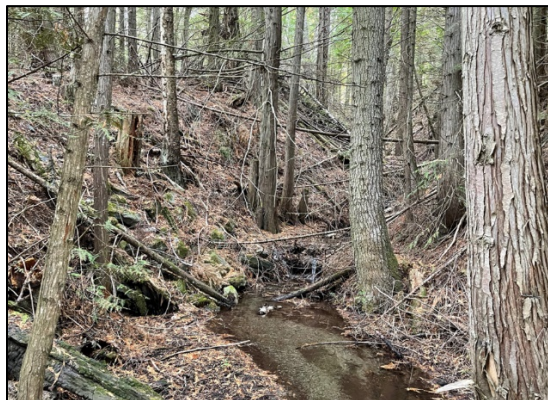
**Photo 24.** View of McGregor Creek channel mid slope on fan

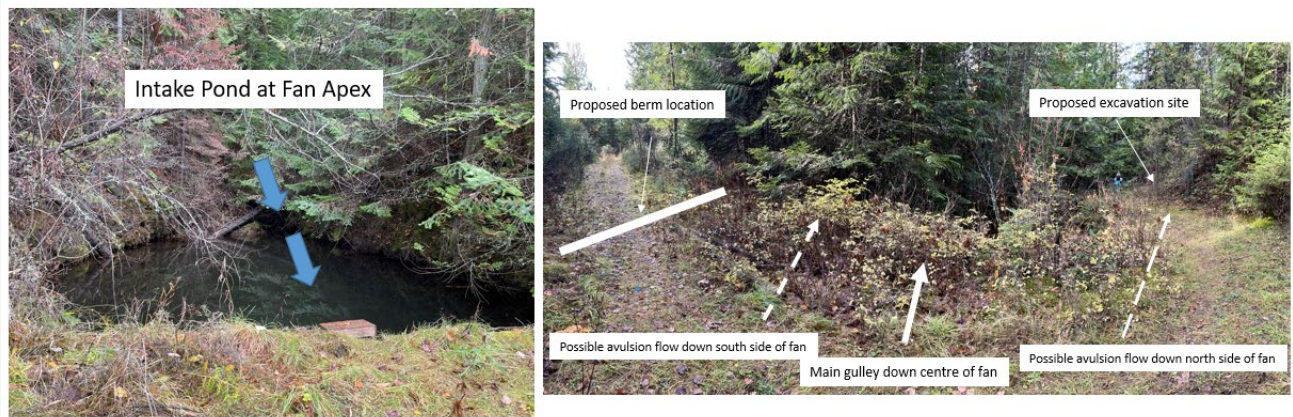
During a debris flow event there is a moderate likelihood that water and debris will be forced out of the gully by this obstruction resulting in overland flow down the south or north side of the fan towards the houses resulting in a MODERATE TO HIGH PARTIAL RISK TO THE HOUSES/RESIDENTS. The likelihood of this occurring can be reduced with the removal of the road crossing and water intake pond. In addition, the likelihood of a channel avulsion at this location could be reduced by the construction of a berm across the road on the south side of the channel and an excavation of material on the north side as shown in Photo 25. The berm on the south side would reduce the likelihood of debris flow material flowing down the fan towards the house at 12185 Hwy 3A. The excavation on the north side would encourage overflow from the gully on the north side to flow to the north into an open field away from the three houses (12260, 12220 & 12252) and the cemetery. Photo 26 is a photograph of the open field on the north side of the fan.

**Photo 25.** Water intake pond and road crossing at apex of McGregor Creek fan

Individual home owners may be able to further mitigate the hazard by constructing a debris flow deflection berm or berms upslope of their house provided the berm(s) does not re-direct flows or debris towards other residences on the fan (refer to Recommendations Section 8.3).

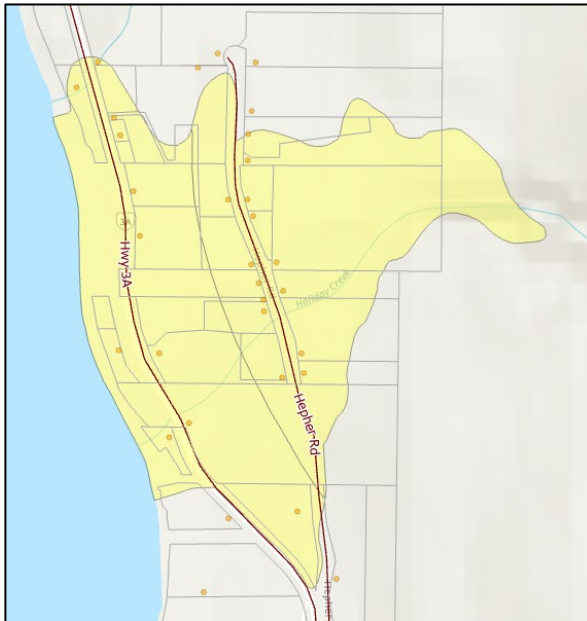
Figure 7A, taken from the RDCK webmap, indicates that there are eight houses on the east (upslope) side of Hephher Road, 14 houses between Hephher Road and Hwy 3A and three houses between Hwy 3A and the lake. The fan boundaries estimated using LiDAR imagery (Figure 7B) shows similar house numbers except for 9 houses (instead of 3) between Hwy 3A and the lake. The exact fan boundary was not located in the field. The boundaries presented in Figures 7A and 7B should be taken as approximations - houses located near the boundary could still be at risk even if shown to be located outside the delineated fan boundary.

**Figure 7A.** Source RDCK webmap

Based on the above observations and interpretations, there is estimated to be a MODERATE TO HIGH PARTIAL RISK TO THE HOUSES/RESIDENTS located above Hepher Road and a MODERATE PARTIAL RISK TO THE HOUSES/RESIDENTS below Hepher Road.

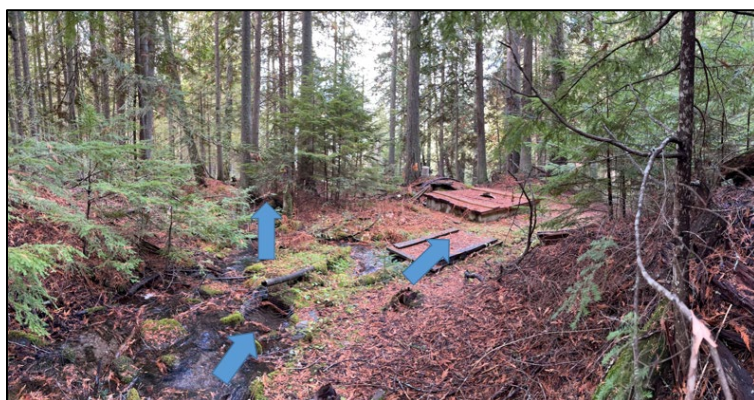
**Photo 27.** View looking downslope (west) at water intake on Holiday Creek

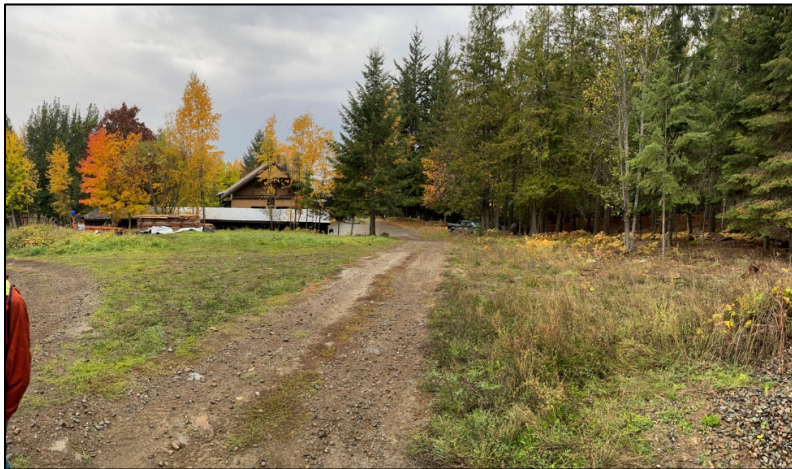
While the overall fan surface gradient from the apex to the lake is 19%, the gradient from the apex to just above Hwy 3A is 15%. The dwelling at 12734 Hwy 3A is located approximately 400 m from the apex of the fan. The fan surface gradient upslope and proximal to the dwelling ranges from 8% to 14%. The PARTIAL RISK IS CONSIDERED LOW for this house location. This lower gradient and distance between the house and the apex of the fan, as well as the absence of gully features (Photo 29) that could direct flow towards the house renders the likelihood of debris flow material other than shallow slow moving sediment laden floodwaters reaching the houses as low.

**Photo 29.** View looking north at house at 12734 Hwy 3A. The fan slopes east to west. The house is located approximately 400 m from the apex of the fan.

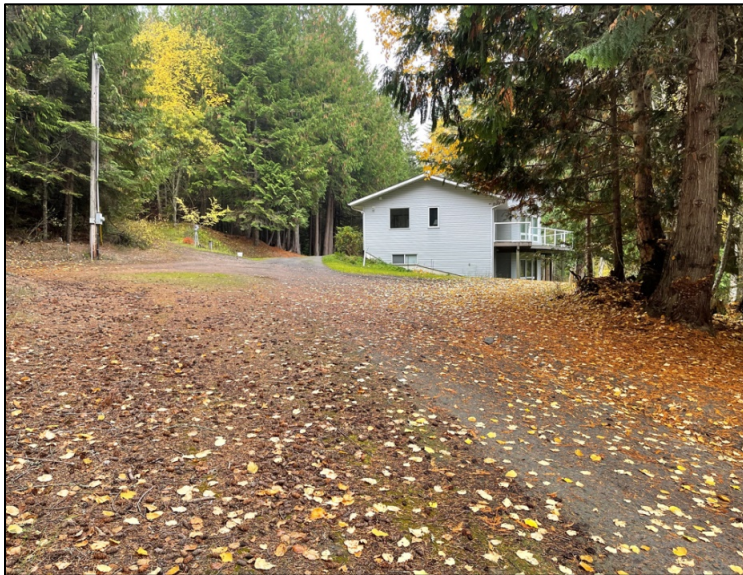
The dwelling at 12850 Hwy 3A (Photo 30) located approximately 240 m from the apex of the North Mack Creek is also assessed with at LOW PARTIAL RISK. The fan surface gradient at the house is 16% and there are no gully features to direct flow towards the house.

**Photo 30.** View looking south at house at 12850 Hwy 3A. The fan slopes left to right. The house is 240 m from the apex of the North Mack Creek fan.

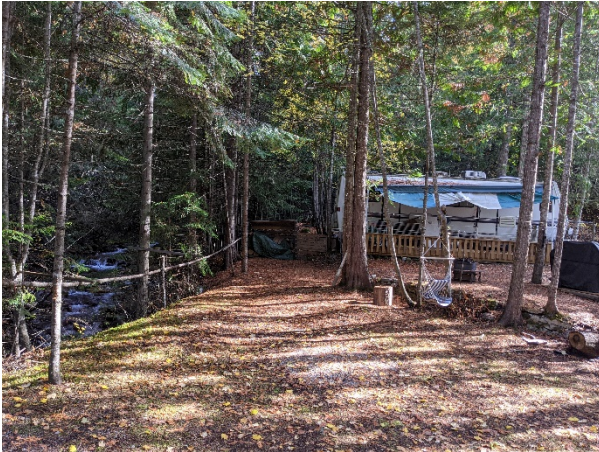
While the incremental post wildfire hazard is considered low, if a large event were to occur the potential for the creek flows to be diverted out of the creek channel at the fan apex is considered high resulting in a MODERATE PARTIAL RISK to the local buildings. Consideration should be given by BC Parks to increase the freeboard at the fan apex to reduce the likelihood of the creek being diverted down the left side of the fan towards the cabins and houses (refer to Recommendations Section 8.2).

**Photo 33.** Lockhart Creek fan apex
