SC-8001

CLOWHOM 7.1km

2019 Inspection

| Crossing Name | Bear Creek | | |

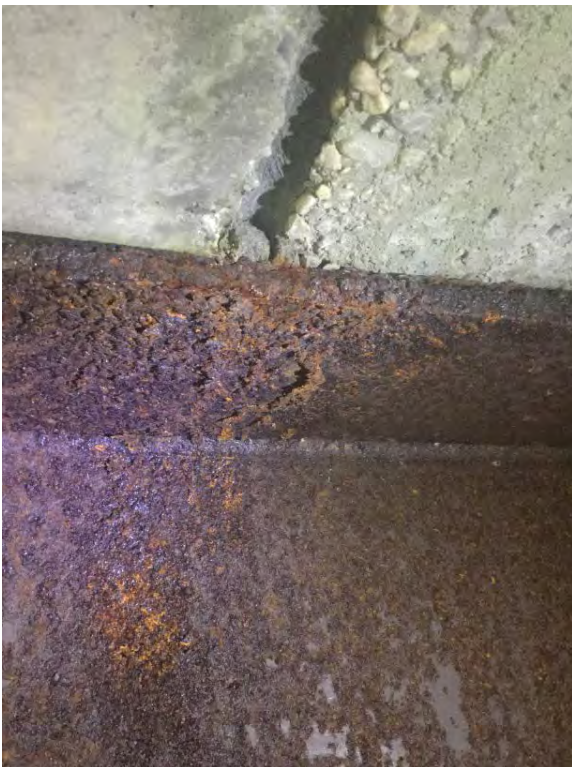
Both girders bowed towards downstream at middle. Both upper and lower flange, both sides. Likely done during installation, prior to placing deck. Estimated 10cm at midspan. Bolts bent on right abutment, towards right side. No apparent change since last inspection. Rust scale behind right abutment bearing, at end of bridge. Some joints have rust scale on upper flange. Monitor.

Both girders bowed towards downstream side. Rust scale behind right abutment, upstream and downstream sides. Scale on some joints., top flange.

Typical rust scale at joint (upper flange)

| Item | Monitor Description | Frequency |
|---|---|---|
| 1 | Monitor corrosion, abutment, bolts, girders. | Routine Inspection |

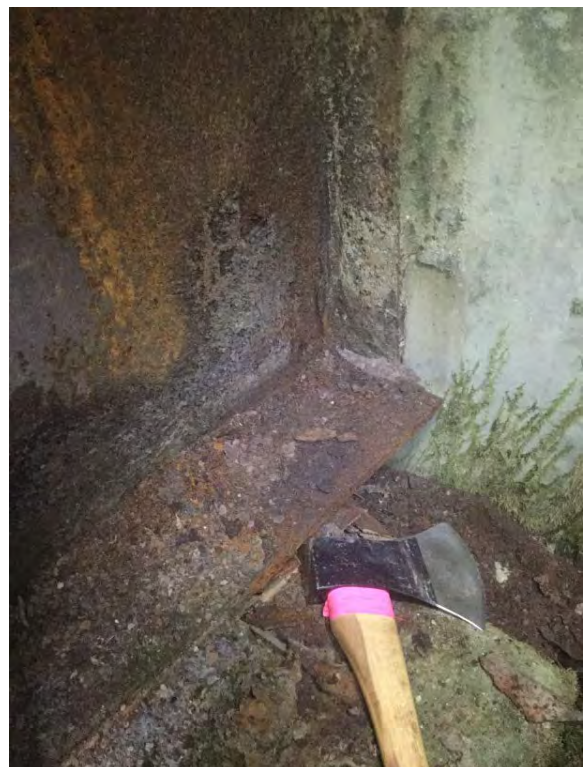
Right Bank Abutment when facing downstream - upstream side heavy rust scale at end of bridge
