SC-8051

MCNAIR 0.8km

2019 Inspection

CBR iPad Offline Ver 0.28

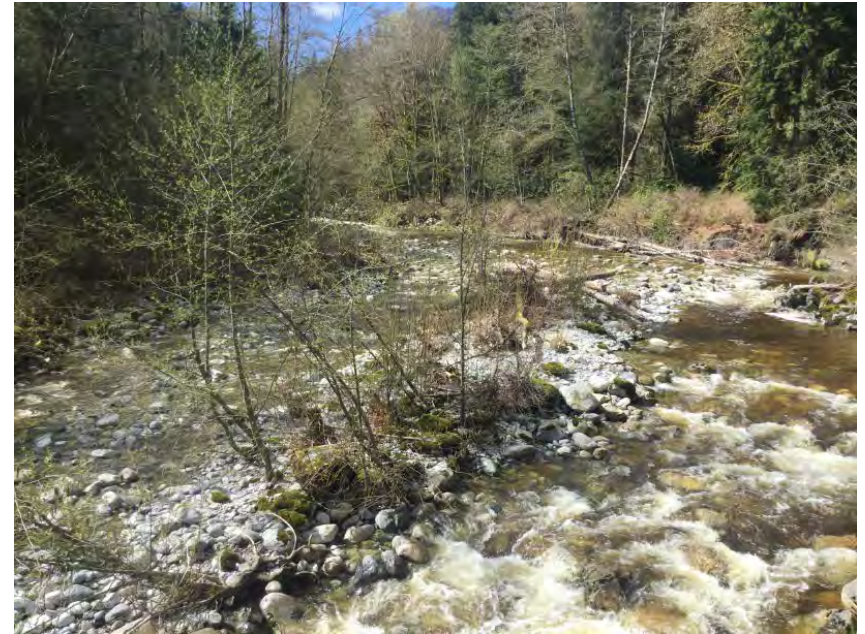
Upstream from Crossing

Unstable channel upstream from crossing. Bank behind upstream riprap bank protection (approx 100m upstream from crossing, on left) has been scoured. May require future assessment and repair.  
Historic high flows. Riprap appears stable. Bridge constricts channel.

| Item | Monitor Description | Frequency |
|---|---|---|
| 1 | Monitor scour upstream. May require repair. | Anually |

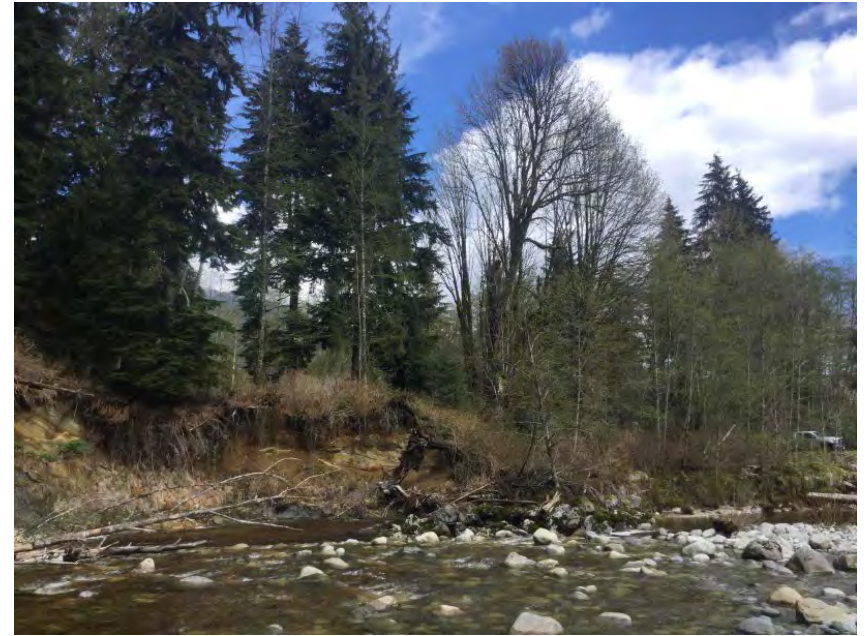
Riprap Fair Heavy riprap extending upstream both sides. Scoured section left side, upstream from crossing.

Upstream from Crossing - left bank upstream from crossing

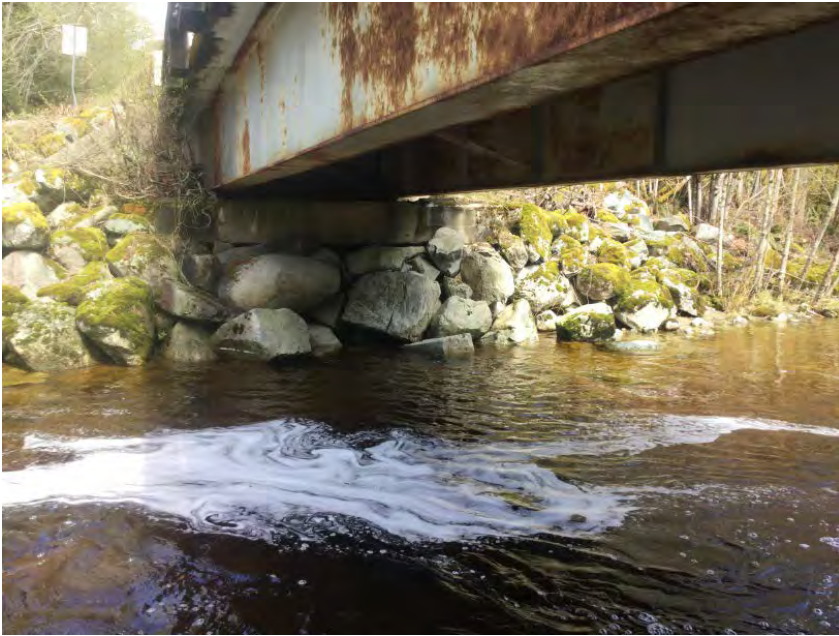
Left Bank Abutment when facing downstream

Corrosion Protection Fair Minor surface rust on painted piles.

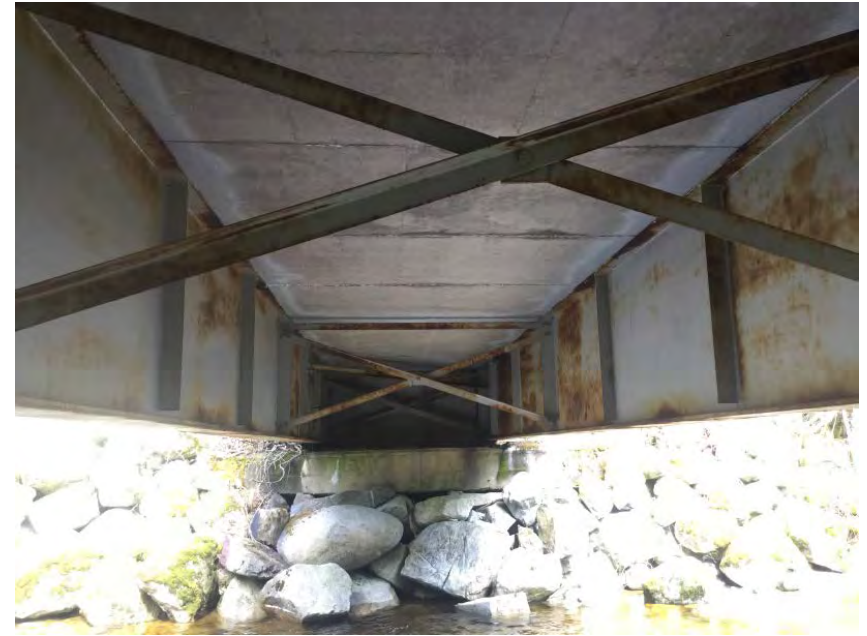
Superstructure

Minor surface rust. Painted superstructure.

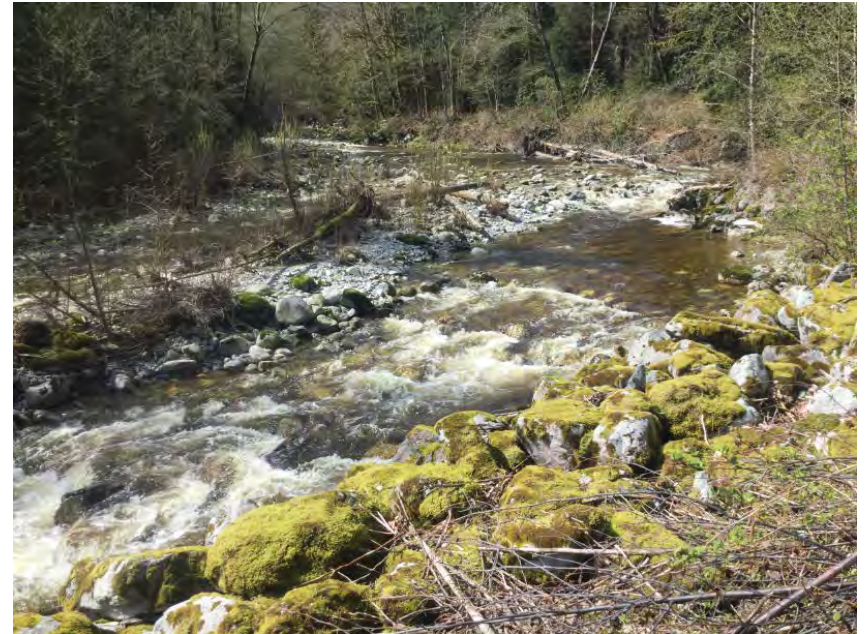
Looking upstream. Note scoured bank on right.

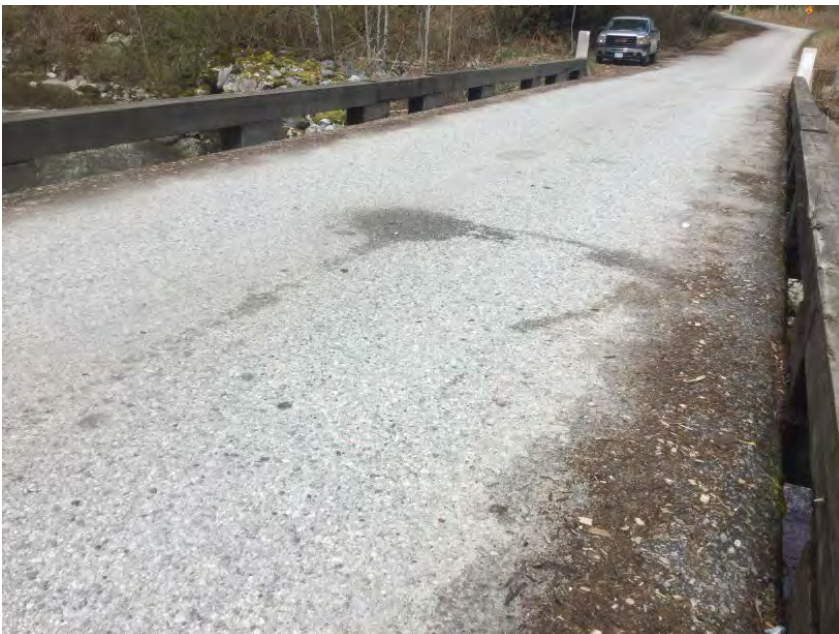
Deck

| Curb Rail/Blocks/Posts | Fair | Treated, but starting to age. |
