SC-8057

MCNAB 10.95km

2019 Inspection

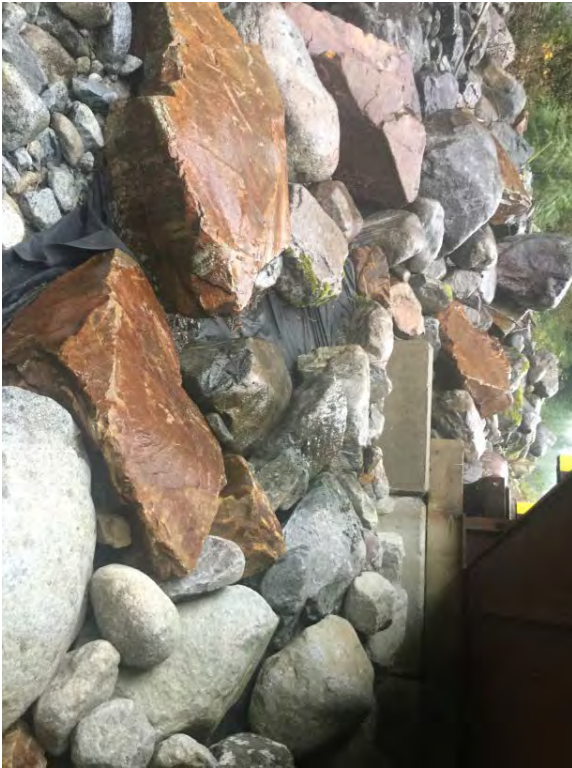
Left Bank Abutment when facing downstream

Riprap Fair Gap ion upstream left. Repair when active in area.

| Repair Item | Priority | Repair Description |
|---|---|---|
| 1 | Low | Repair riprap when machines active in area |
