SC-8059

MCNAB 9.92km

2019 Inspection

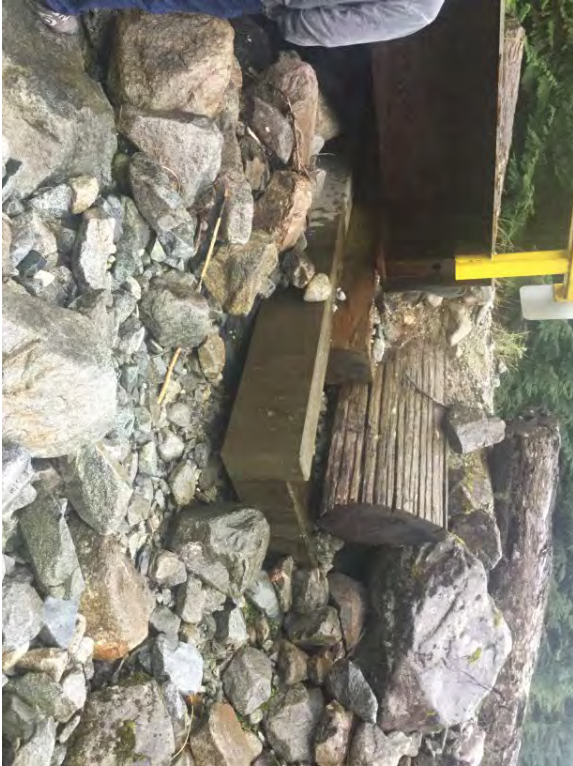
Right Bank Abutment when facing downstream

Caps or Sills Poor Undermined / scoured right side upstream

Riprap Poor Scoured right side.

Bearings Fair I undermined on right upstream

| Repair Item | Priority | Repair Description |
|---|---|---|
| 1 | High | Repair riprap and right upstream footing. |

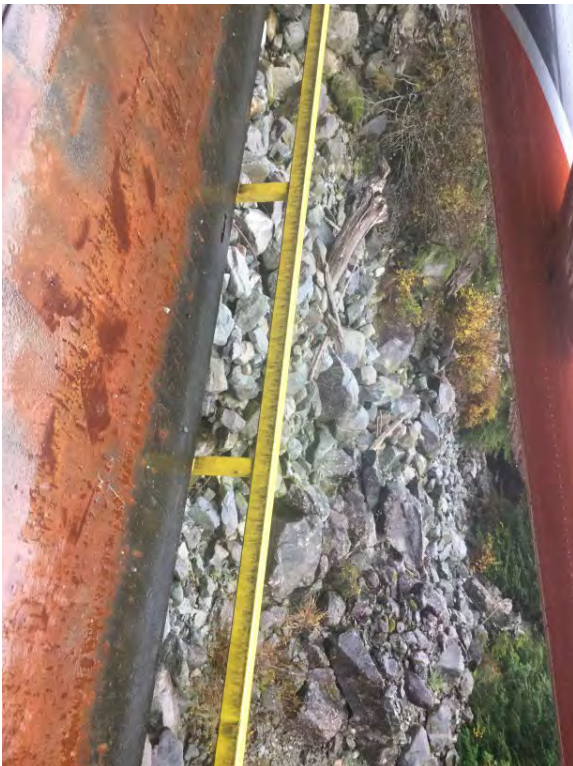
Upstream Profile

Riprap almost completely gone on right side. Footing undermined on right side, upstream. Large amount of boulders upstream, could Impact bridge if migrates. Remove. Repair riprap and footing prior to industrial use.

2 Medium Remove debris upstream channel
