SC-8061

MCNAB 11.94km

2019 Inspection

| Structure Class | Major Culvert |

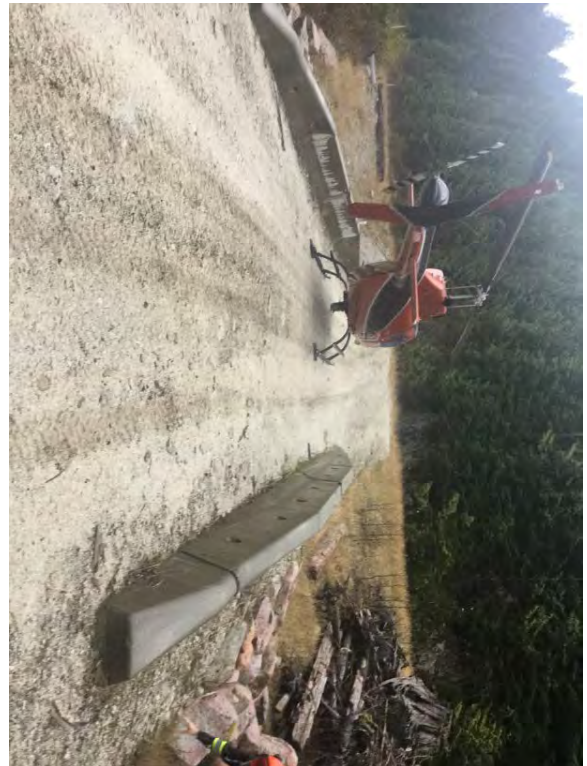
Approach from Right Bank when facing downstream

Delineator Missing  
Left ☐ 0 ☐ 1 ☒ 2

Delineator Missing  
Right ☐ 0 ☐ 1 ☒ 2

1 Medium Add delineators to approach barriers
