SC-8070

MIDDLE POINT 2.26km

2019 Inspection

| Crossing Name | Silver Sands Creek |

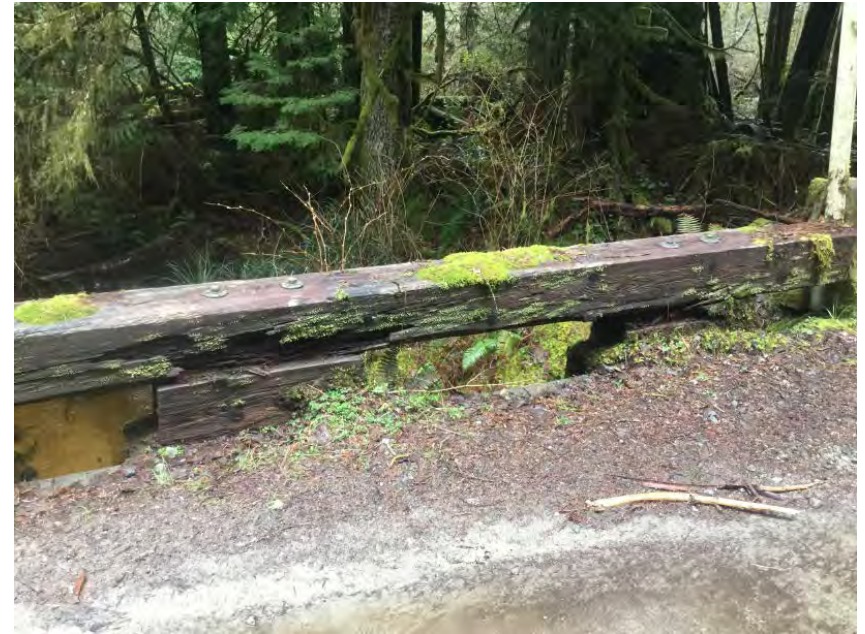
Guard Rail

Curb Rail/Blocks/Posts      **Poor**      Rotten; Replace

| 1 | High | Replace guardrails |

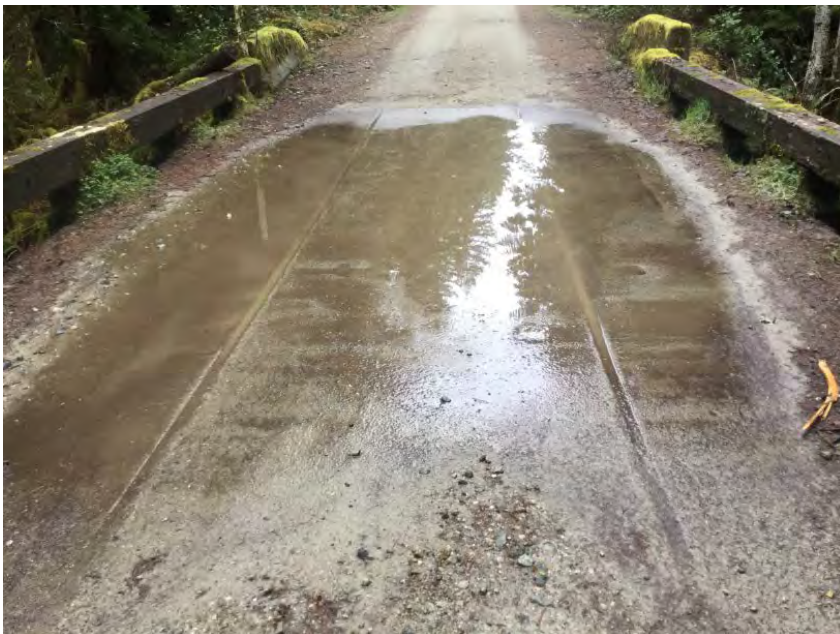
Concrete Deck      **Good**
