SC-8101

RAINY RIVER 0.71km

2019 Inspection

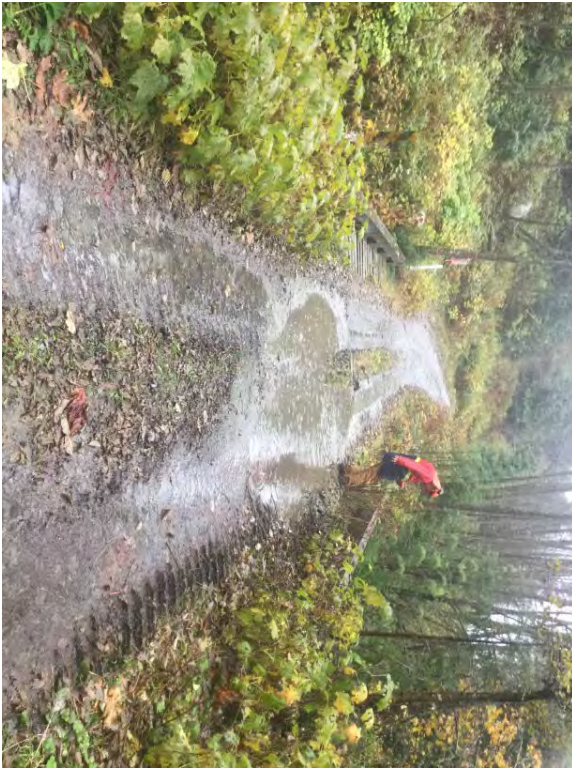
| Overall Deck Condition | Poor | Rotten deck |

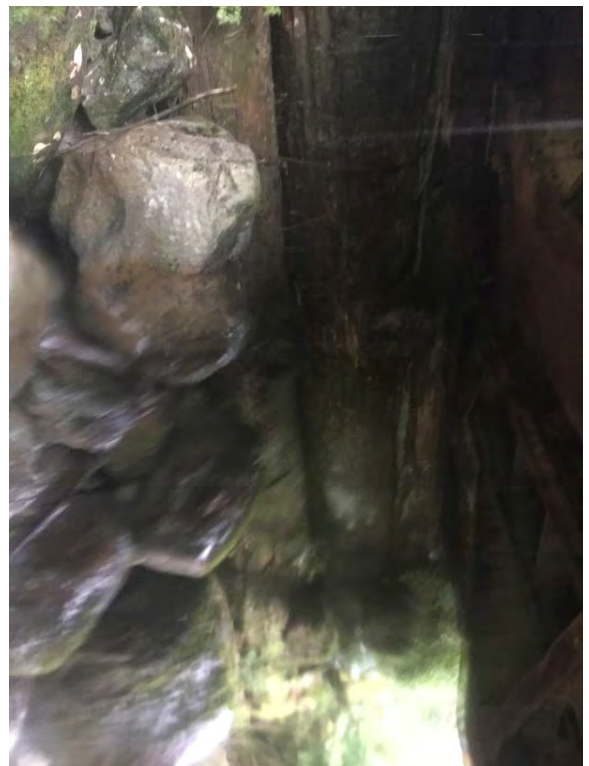
Left Bank Abutment when facing downstream

Log/Timber Cribs Poor Old, scoured, undermined

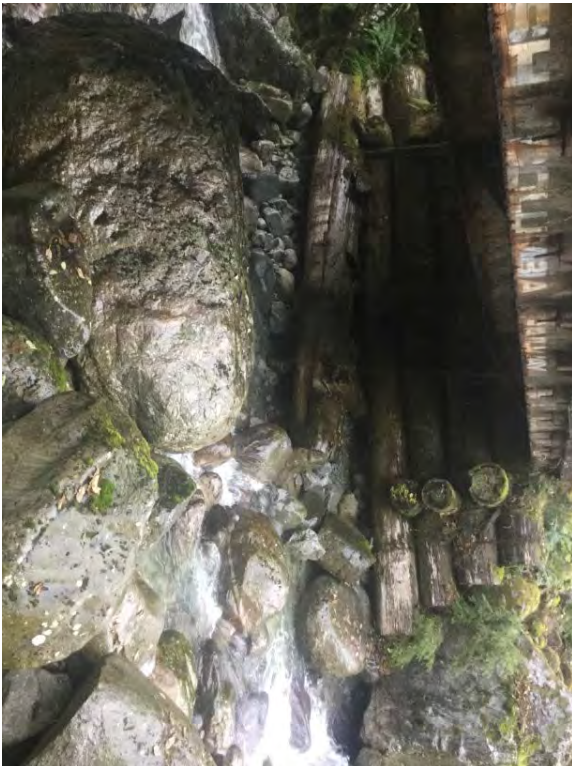
Right Bank Abutment when facing downstream

Riprap Poor Missing on right
