SC-8165

SECHELT WILSON 0.25km

2019 Inspection

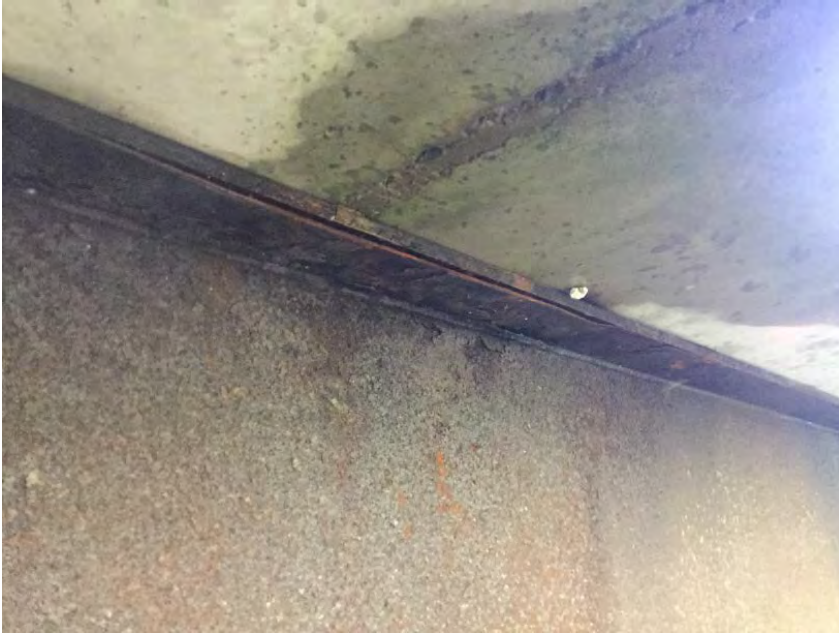
Superstructure

Girders showing advanced rust scale, particularly at abutments and in isolated areas Close proximity inspection and analysis recommended.

Advanced rust scaling on girders

| Item | Monitor Description | Frequency |
|---|---|---|
| 1 | Monitor superstructure corrosion | Routine Inspection |
