SC-8200

THEODOSIA 0.1km

2019 Inspection

| Road Name | THEODOSIA |

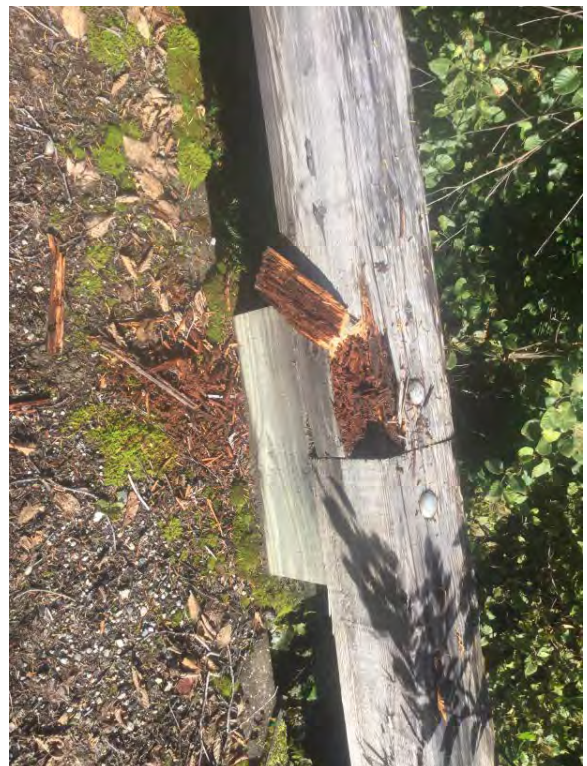
Guard Rail

Curb Rail/Blocks/Posts      Poor      Guardrails fair overall, on section poor (right upstream end). risers and blocks good

Load Rated by: Forrest Simpson, EIT, Mar 4, 2020  
Load Rating: L150 or 136 tonnes  
Next Inspection: 2022  
Comments: Replace rotten guardrail section(s).

| Item | Priority | Repair Description |
|---|---|---|
| 1 | Medium | Replace rotten guardrail section. Replace all within 3 years. |
