SC-8201

THEODOSIA 0.2km

2019 Inspection

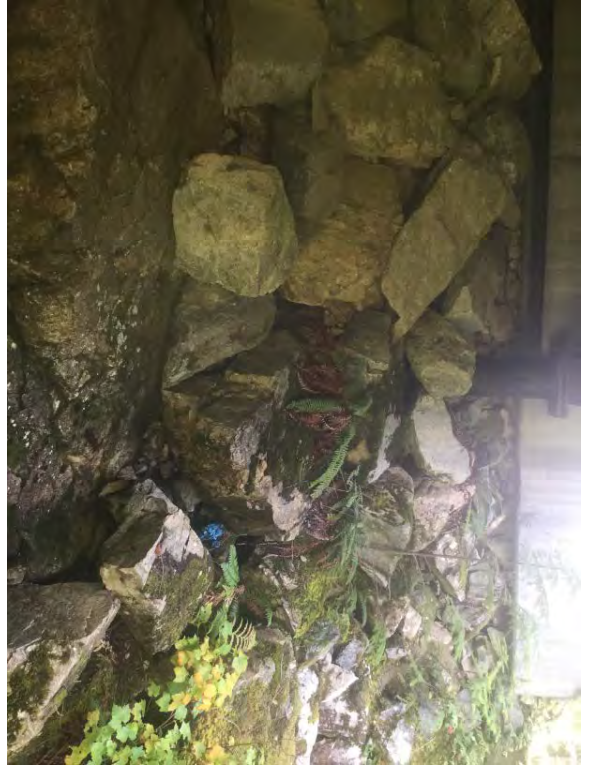
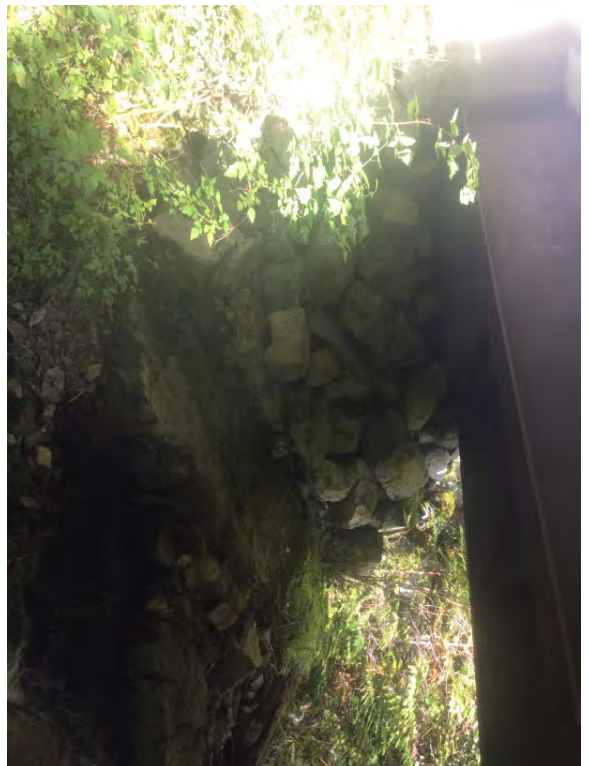
Right Bank Abutment when facing downstream

Riprap Fair Right side undermined at toe, downstream side. Monitor

| Item | Monitor Description | Frequency |
|---|---|---|
| 1 | Monitor riprap right side | Routine Inspection |
