SC-8205

THEODOSIA 2.5km

2019 Inspection

| Road Name | THEODOSIA |

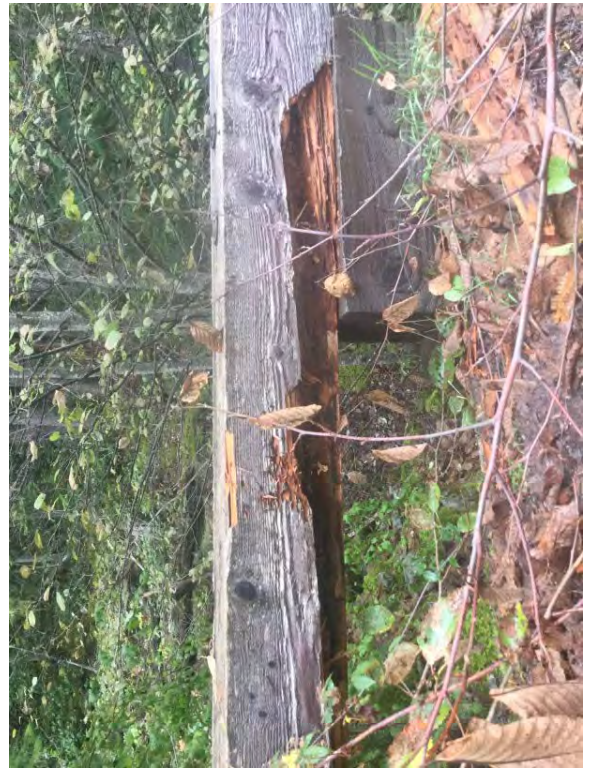
Guard Rail

Curb Rail/Blocks/Posts Poor Rotten

| 1 | High | Replace guardrails |

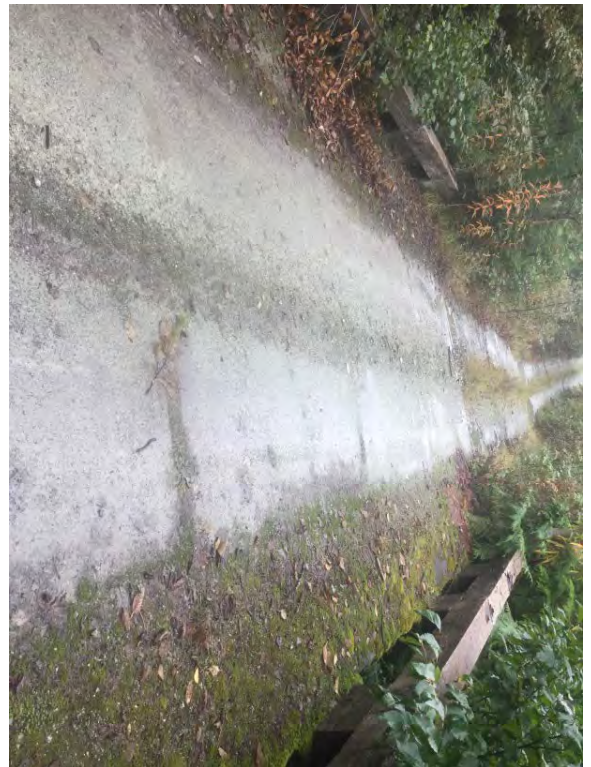
Overall Deck Condition Fair
