SC-8208

THEODOSIA 3.3km

2019 Inspection

| Structure Class | Major Culvert |

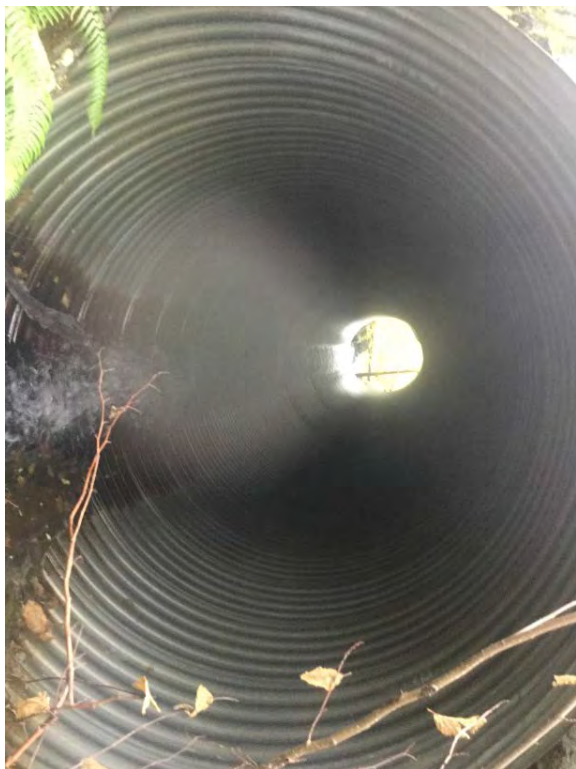
Inlet Fair Some woody debris.

Load Rated by: Forrest Simpson, EIT, Mar 3, 2020  
Load Rating: L165 or 150 tonnes  
Next Inspection: 2022  
Comments: Clear inlet of debris and remove log grizzly if possible.

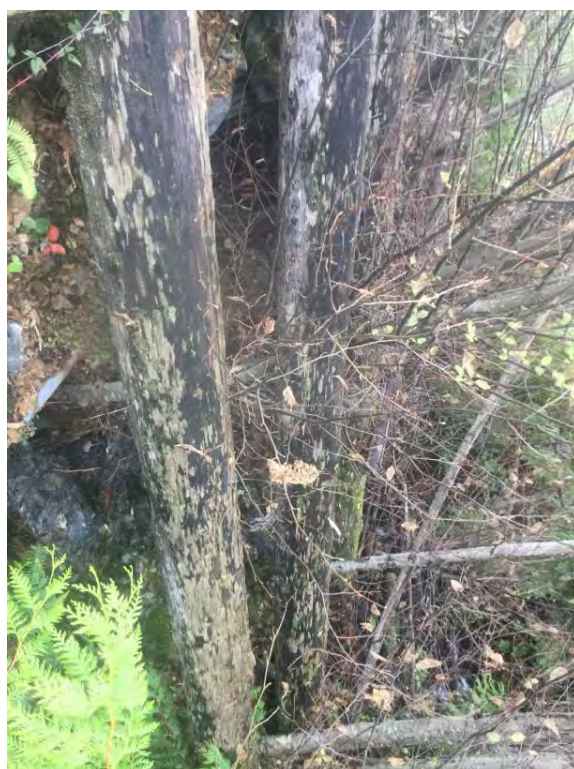
Inlet log grizzly

Log grizzly is rotten. Appears to be unnecessary

Trash Rack Poor Rotten log grizzley

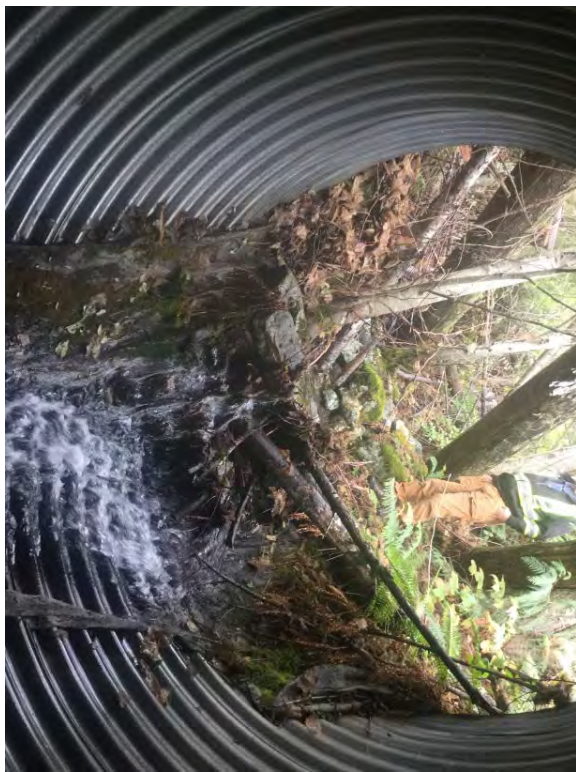
Outlet Good
