SC-8216

THEODOSIA 7.11km

2019 Inspection

Structure Class Major Culvert

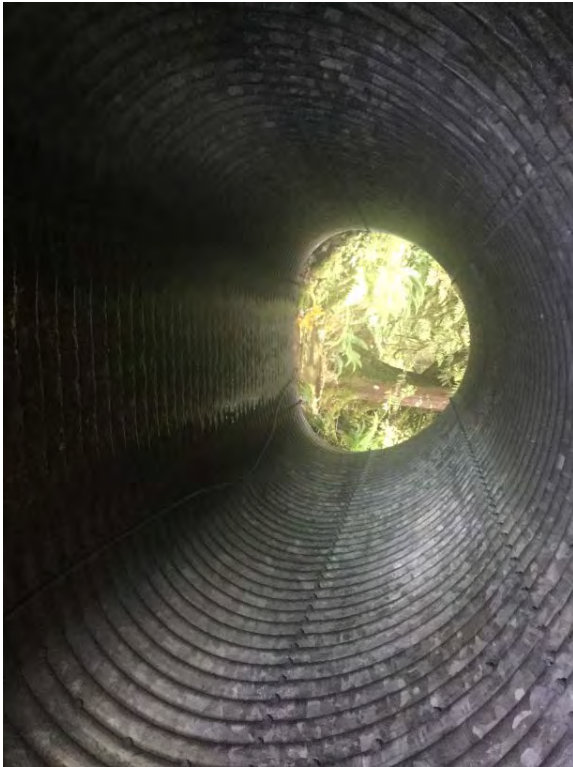
Outlet Good

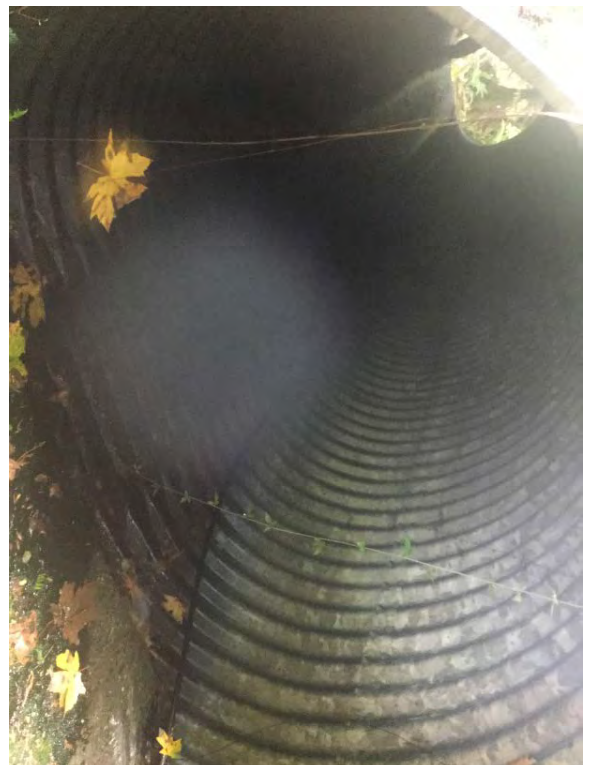
Inlet Good
