SC-8219

THEODOSIA 11.1km

2019 Inspection

Load Rated by: Forrest Simpson, EIT, Mar 3, 2020  
Load Rating: L150 or 136 tonnes  
Next Inspection: 2022  
Comments: Fill pothole on deck.

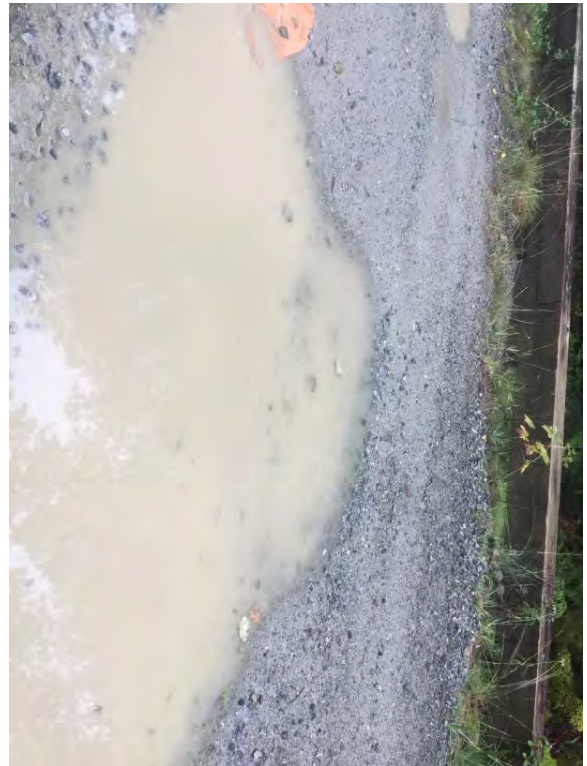
Deck

| Running Surface | Fair | Large pothole. |

| Item | Priority | Repair Description |
|---|---|---|
| 1 | Medium | Fill pothole on deck |

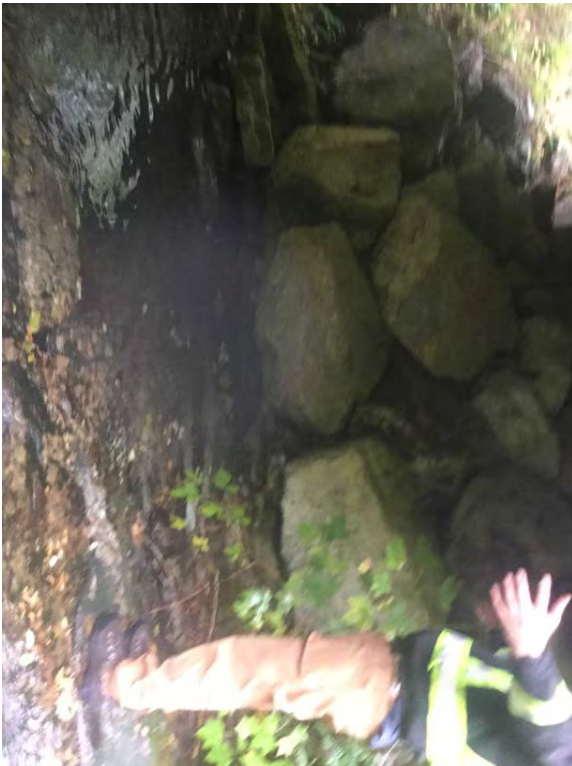
Right Bank Abutment when facing downstream

Riprap Fair Large, minor undermining on right

| Item | Monitor Description | Frequency |
|---|---|---|
| 1 | Monitor riprap | Routine Inspection |
