SC-8224

THEODOSIA 0.05km

2019 Inspection

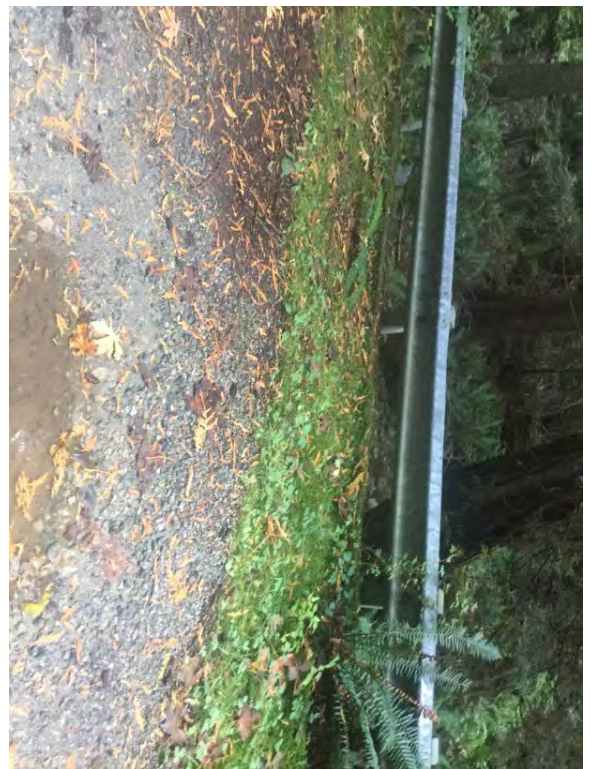
Concrete Deck Unrated Gravel over concrete

Gravel Surface Fair

| 1 | Low | Fill pothole on deck |
