SC-8225

THEODOSIA 0.35km

2019 Inspection

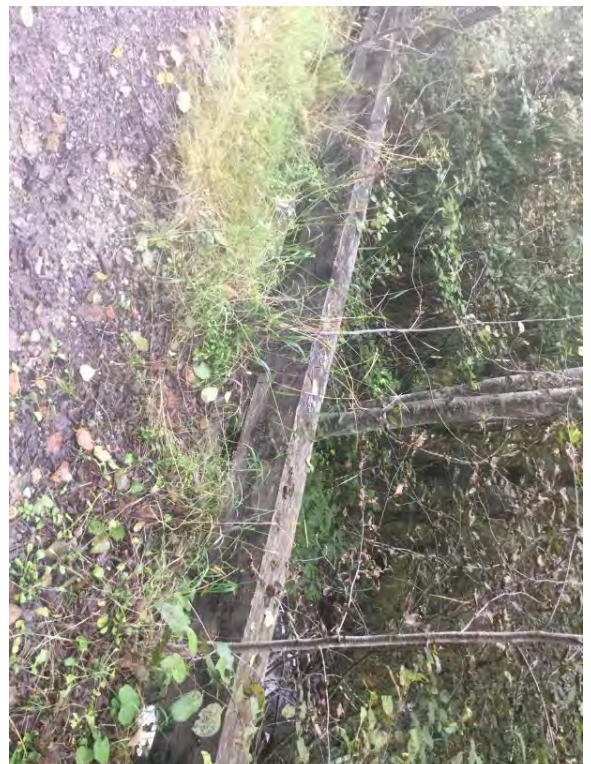
Guard Rail

| Curb Rail/Blocks/Posts | Fair | Risers and blocks good |

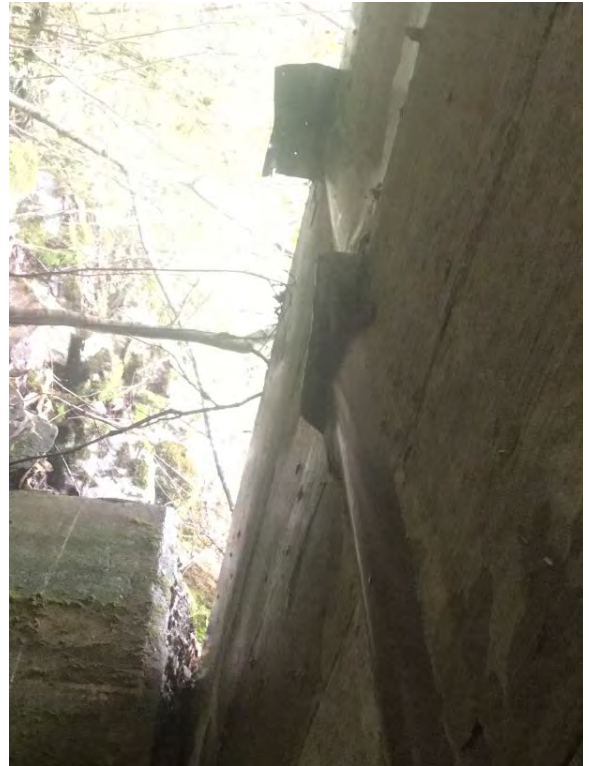
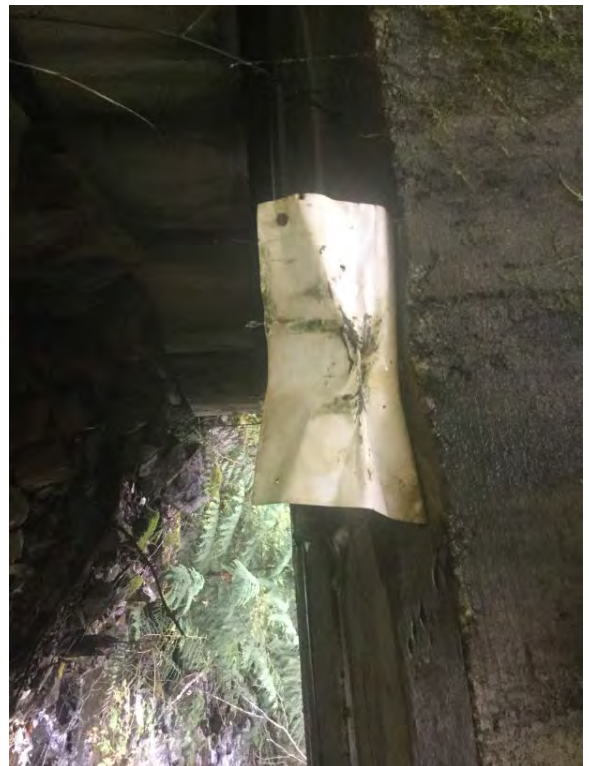
Superstructure

Girders Fair

Flaws in casting, doesn't appear to be compromising integrity
