SC-8226

THEODOSIA 0.65km

2019 Inspection

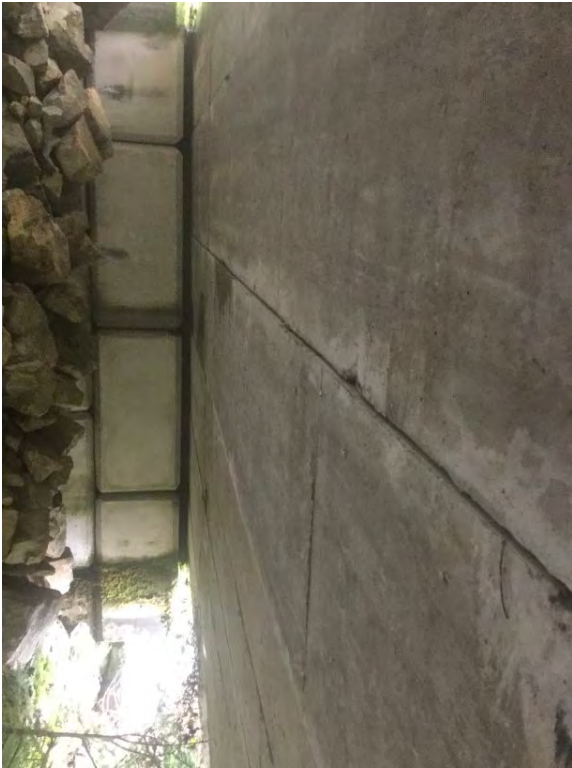
Superstructure

| Curb Rail/Blocks/Posts | Poor | Rotten rails |

Concrete slabs. Flaws in casting

| Repair Item | Priority | Repair Description |
|---|---|---|
| 1 | High | Replace guardrails |

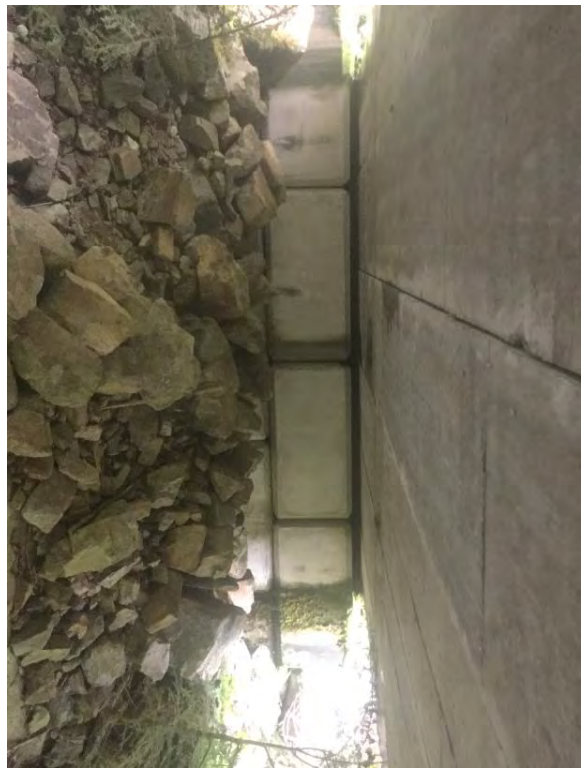
Left Bank Abutment when facing downstream

Caps or Sills Fair Treated timber

Bearings Fair Treated timber
