SC-8229

THEODOSIA 1.3km

2019 Inspection

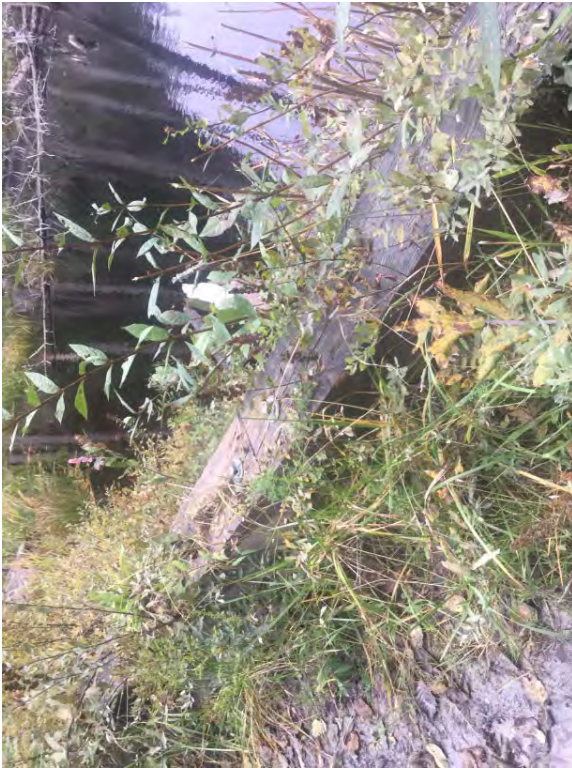
Guard Rail

Curb Rail/Blocks/Posts      Poor      Rotten

| 3 | High | Replace guardrails |

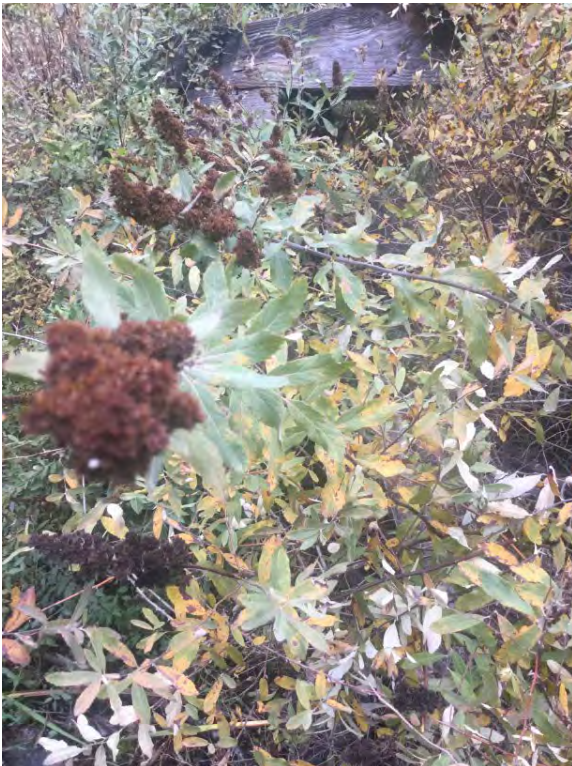
Inlet

Beaver dam at inlet. Consider removing.

| 1 | Low | Remove beaver dam at inlet |

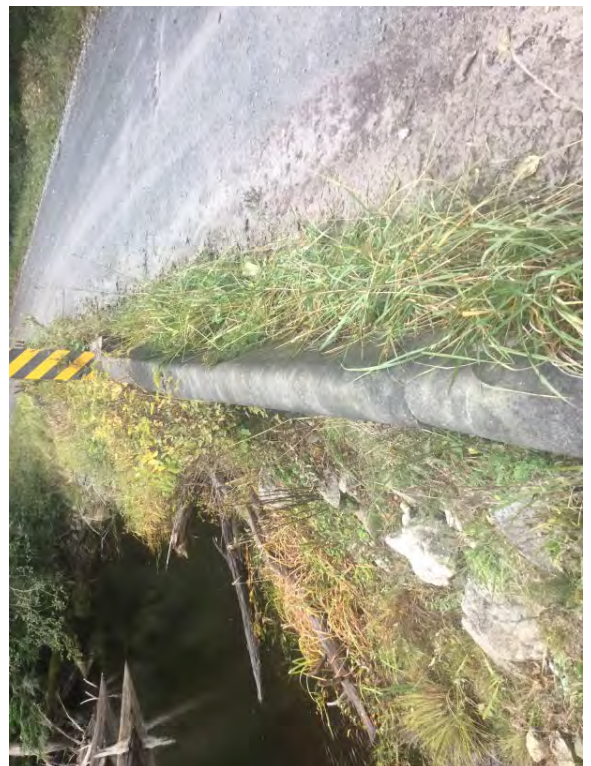
Approach Barrier

Fender Condition Poor

Leaning out on upstream side

| 2 | Low | Re- set no post barriers. Add delineators |
