SC-8230

THEODOSIA 1.5km

2019 Inspection

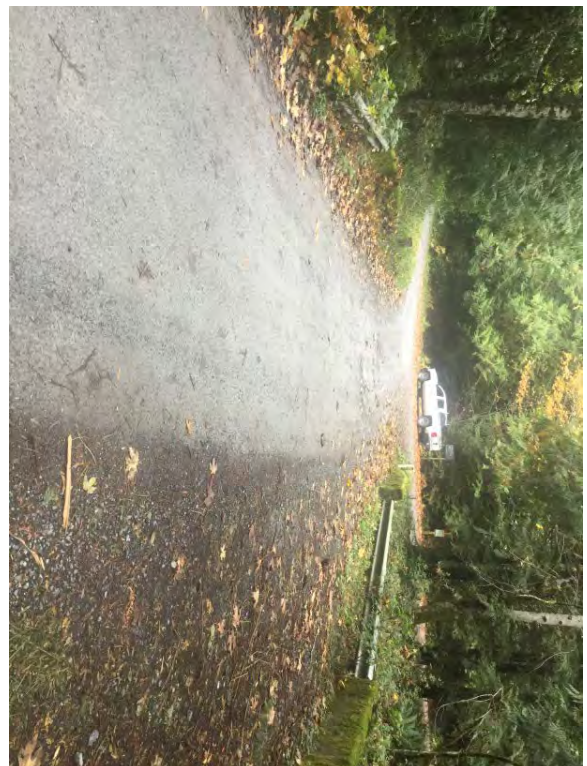
Approach from Left Bank when facing downstream

Delineator Missing  
Left ☐ 0 ☒ 1 ☐ 2Delineator Missing  
Right ☒ 0 ☐ 1 ☐ 2

| 1 | Medium | Add delineator |
