SC-8242

THEODOSIA 11.52km

2019 Inspection

| Crossing Name | Junction Creek |

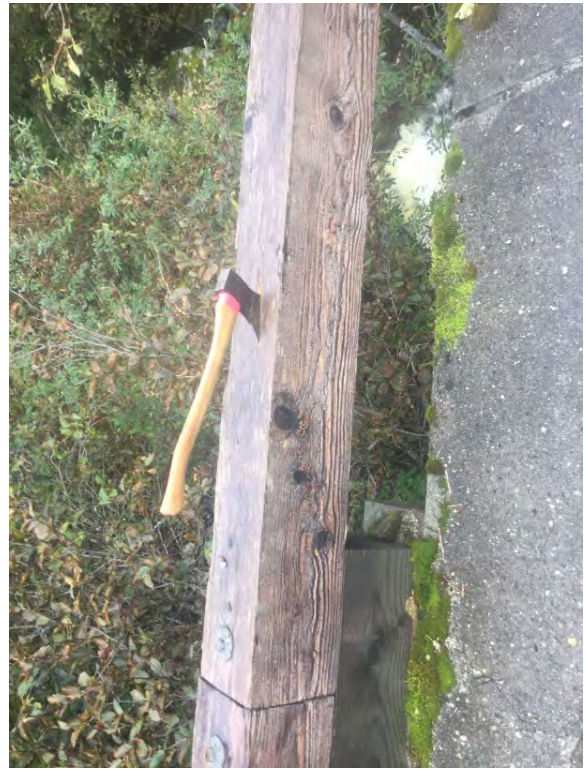
Guard Rail

Curb Rail/Blocks/Posts      Fair      Risers / side locks good (treated), rails fair
