SC-8332

HALLOWELL 0.59km

2019 Inspection

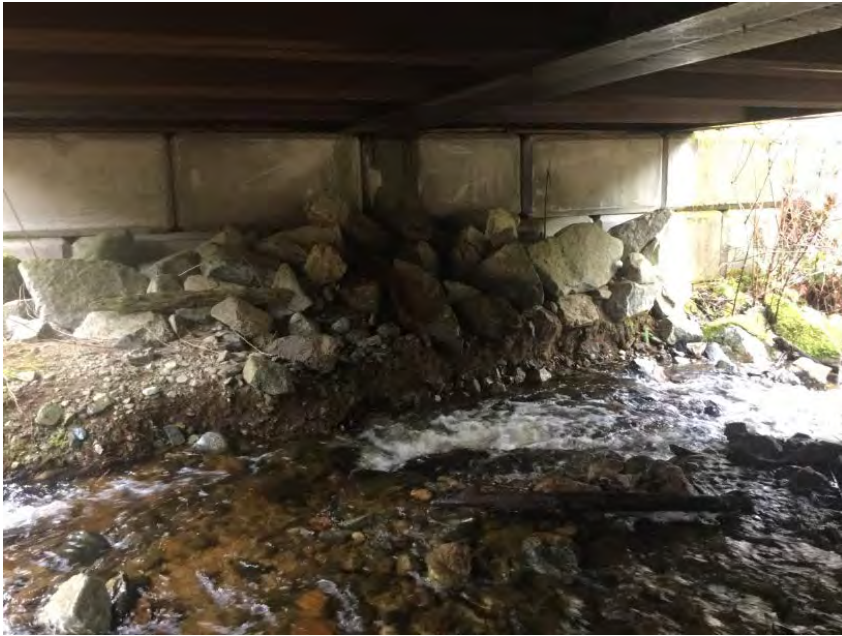
Left Bank Abutment when facing downstream

Riprap Fair Eroded left side. Monitor

Bearings Fair 1x10 cedar boards crushing

| Item | Monitor Description | Frequency |
|---|---|---|
| 1 | Monitor riprap left abutment for scour | Routine Inspection |
| 2 | Monitor sills for crushing | Routine Inspection |
