SC-8333

HALLOWELL 0.72km

2019 Inspection

| Structure Class | Temporary Bridge |

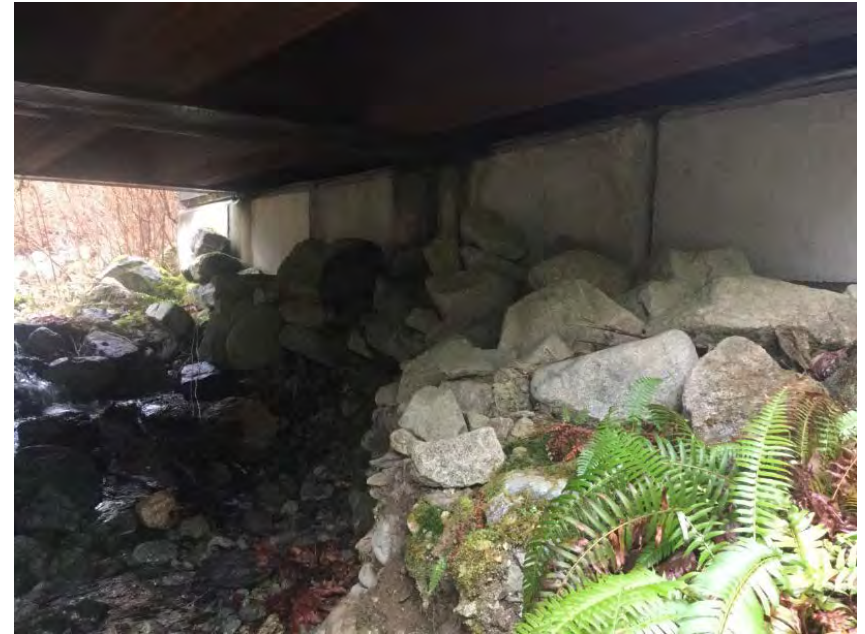
Left Bank Abutment when facing downstream

Riprap **Fair** **Partially eroded. Monitor.**

| Item | Monitor Description | Frequency |
|---|---|---|
| 1 | Monitor riprap | Routine Inspection |
