SC-8334

HALLOWELL 0.83km

2019 Inspection

| Structure Class | Temporary Bridge |

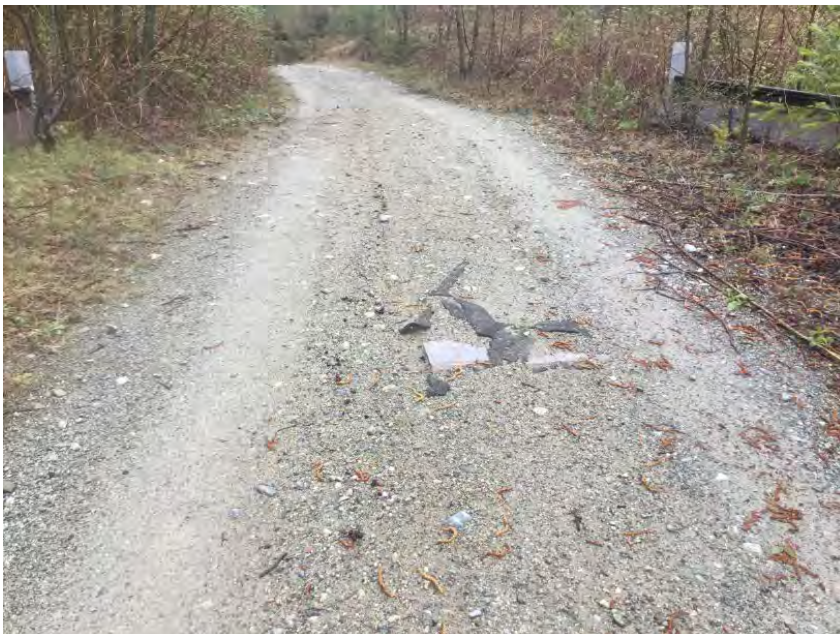
Deck

Gravel Surface      Fair

| 2 | Low | Add gravel to deck prior to industrial use |

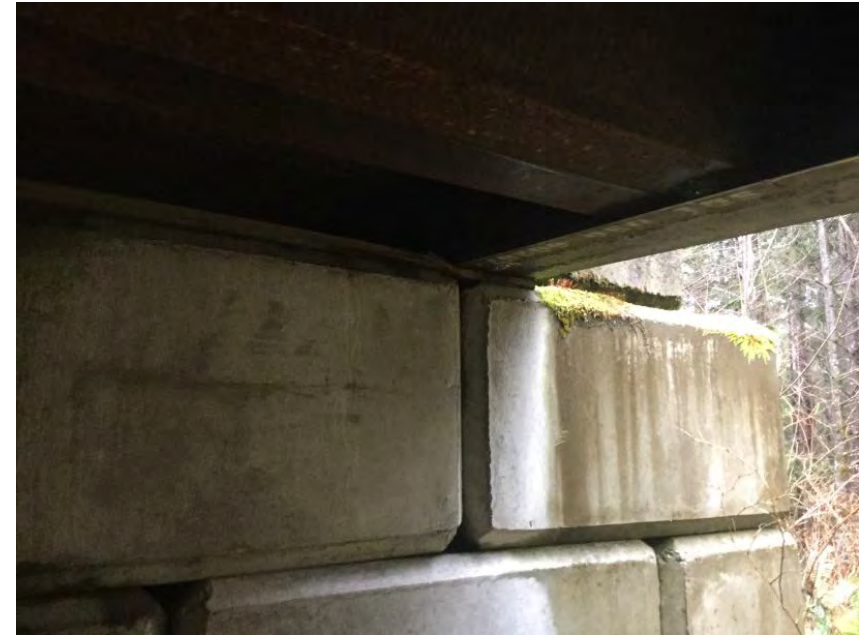
Bearing

Bearings Fair Treated 2x10. Crushing.

| Item | Monitor Description | Frequency |
|---|---|---|
| 1 | Monitor bearings for further crushing and settlement. Monitor downstream right sill for shifting off lock block abutment. | Routine Inspection |

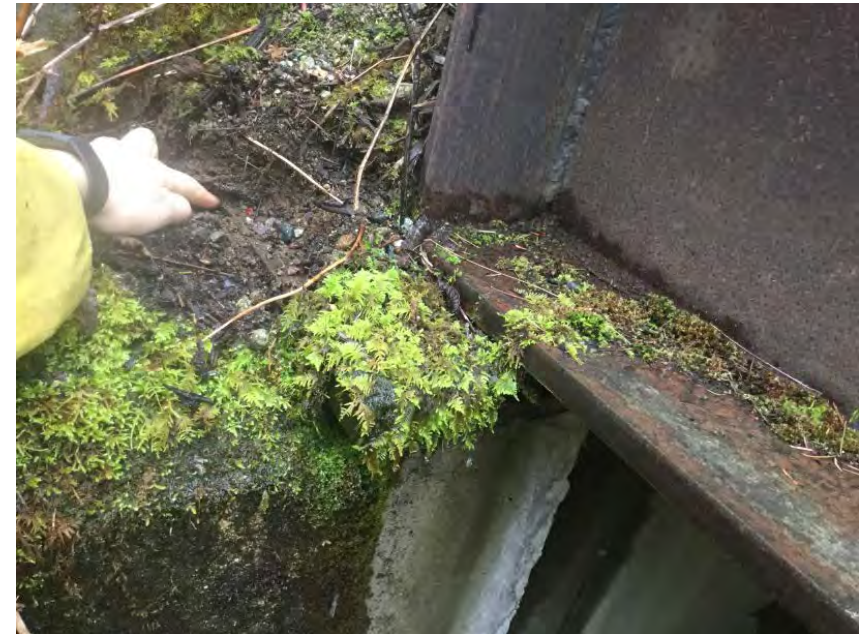
Bearing - note bearing plate note completely on lock block (back of plate indicated on photo)
