SC-8337

SECHELT CREEK 0.2km

2019 Inspection

CBR iPad Offline Ver 0.31

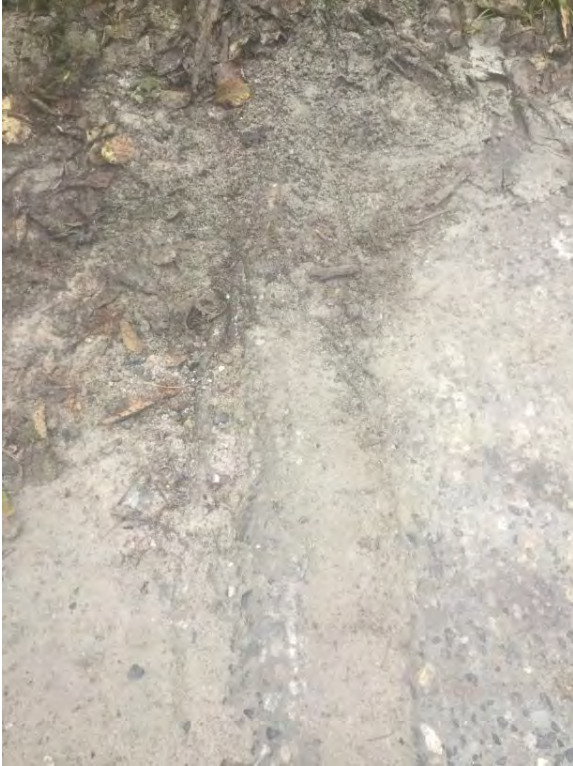
Right Bank Abutment when facing downstream - damaged ballast wall

| 2 | Medium | Repair concrete ballast wall and deck, both approaches. |

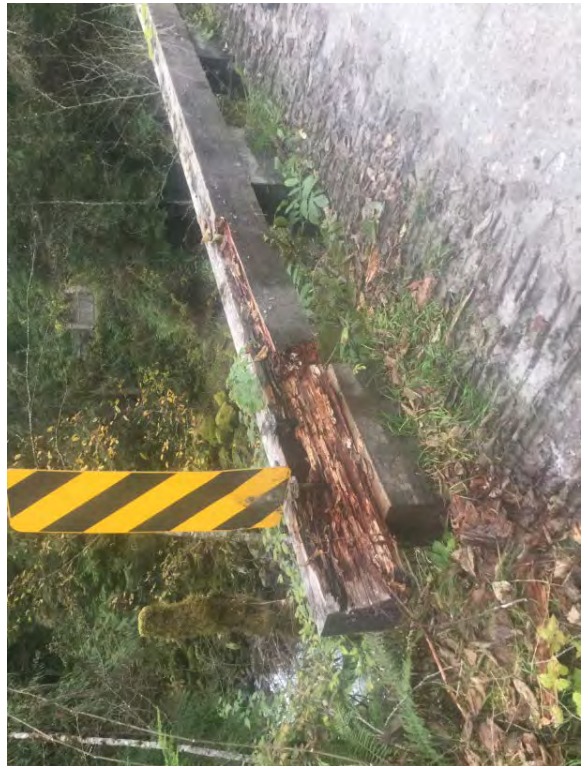
Curb Rail/Blocks/Posts Poor Rotten, replace

Guard Rail

| 1 | High | Replace guardrails |

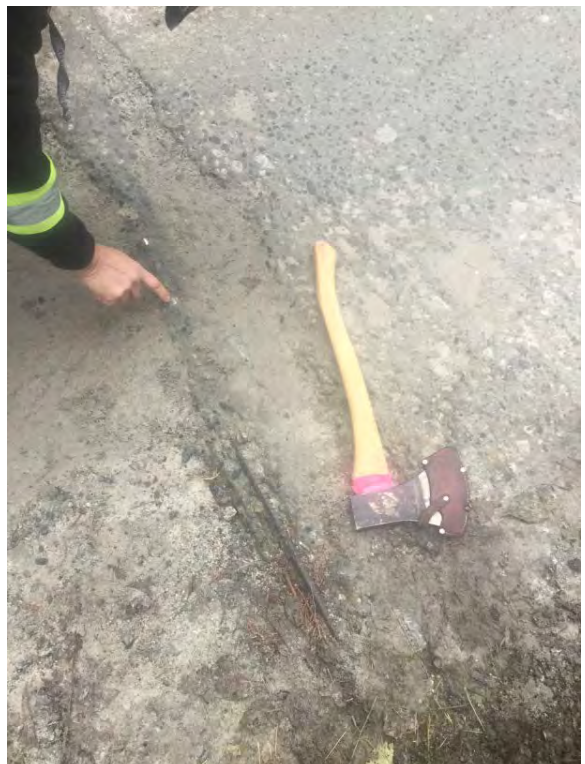
Right Bank Abutment when facing downstream - damaged ballast wall

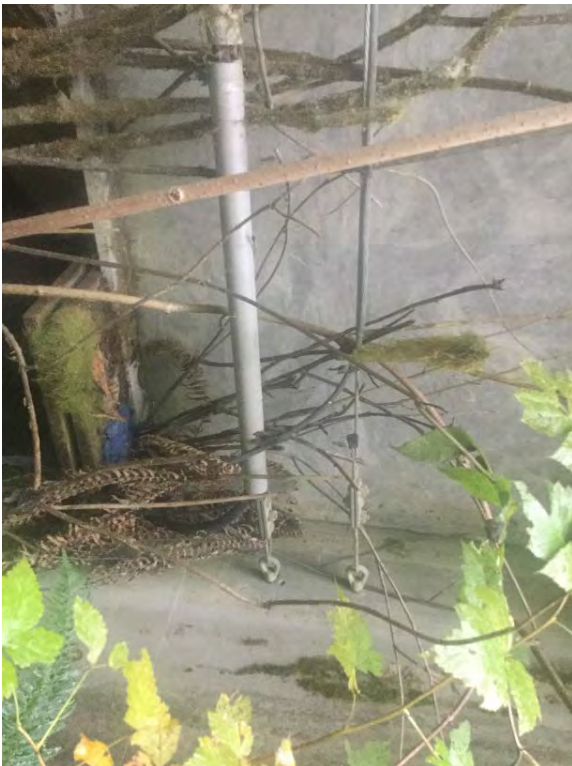
Power cable running behind right ballast wall

Power cable running on upstream side.

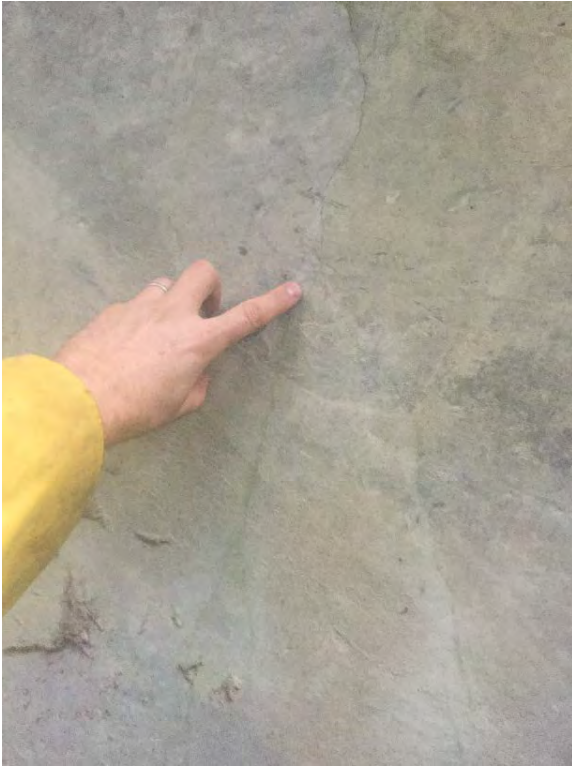
Hairline cracking in concrete web, downstream left

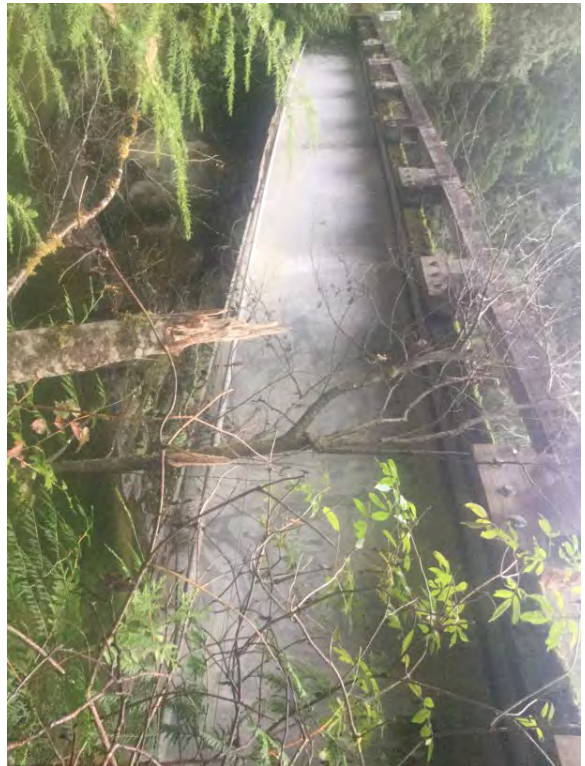
Power cable running on upstream side.

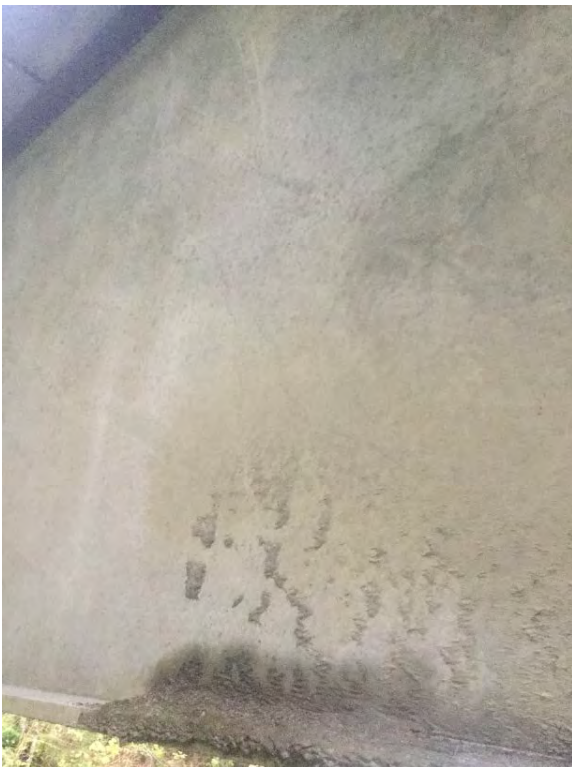
Hairline cracking in concrete web, downstream left
