SC-8523

LOIS 1.4km

2019 Inspection

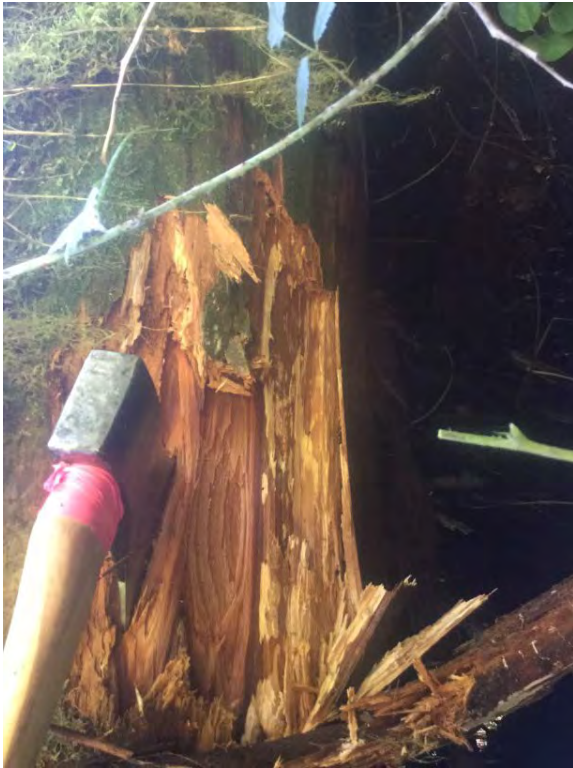
Old cedar stringers. No apparent change since last inspection. 20mm sap rot on accessible stringers (outside on either side). Possible beaver or animal denning under bridge (litter and debris pile). Consider replacement, possibly with embedded pipe. Low velocity stream.

Outside stringer

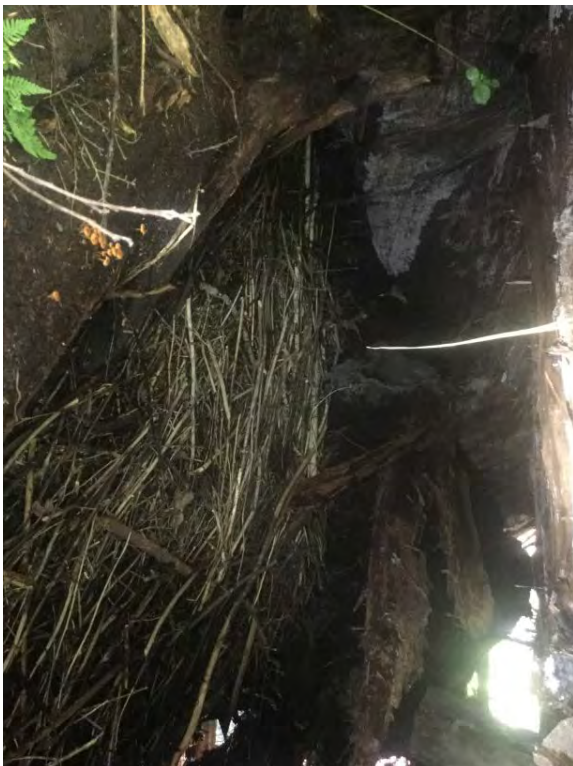
Right Bank Abutment when facing downstream

Caps or Sills Fair Cedar logs. Mud sills on left side.
