SC-8586

LOIS-ST VINCENT 5km

2019 Inspection

**Culvert**

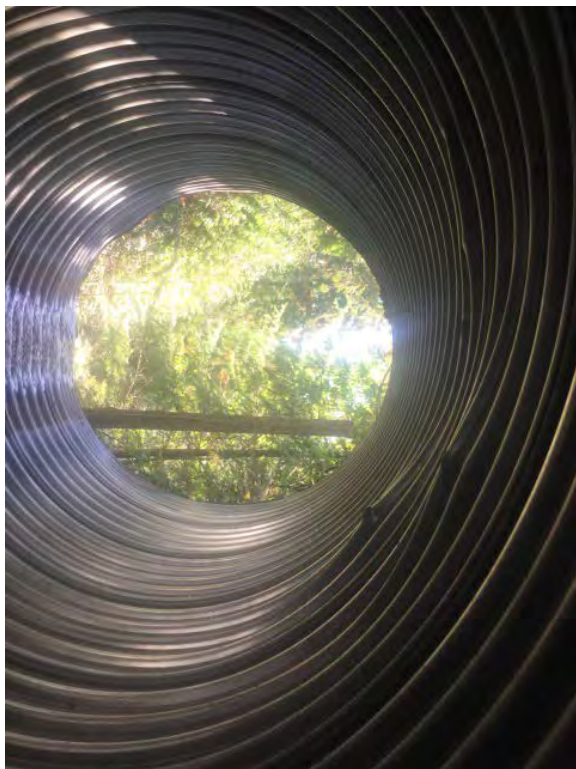
| Outlet | Good | Unable to look under pipe, too steep. Appears ok from in pipe |

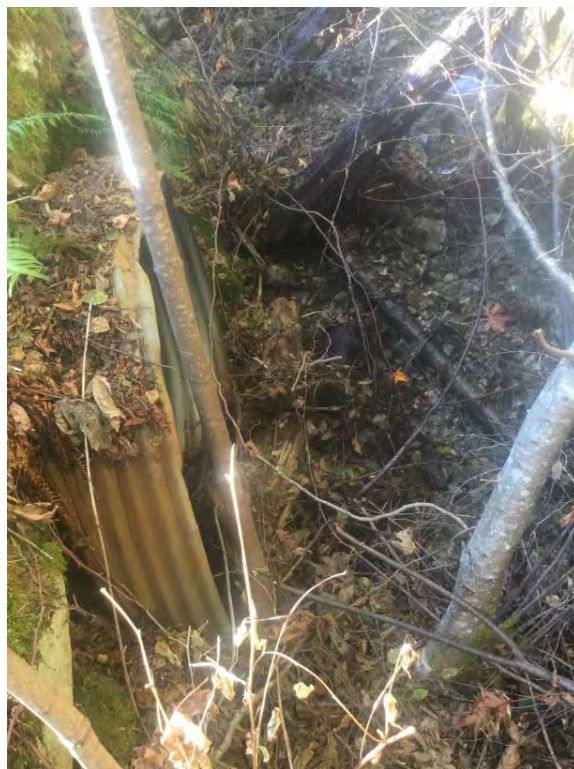
| Inlet | Fair | Small woody debris at inlet. |
