SC-8611

THEODOSIA 3.6km

2019 Inspection

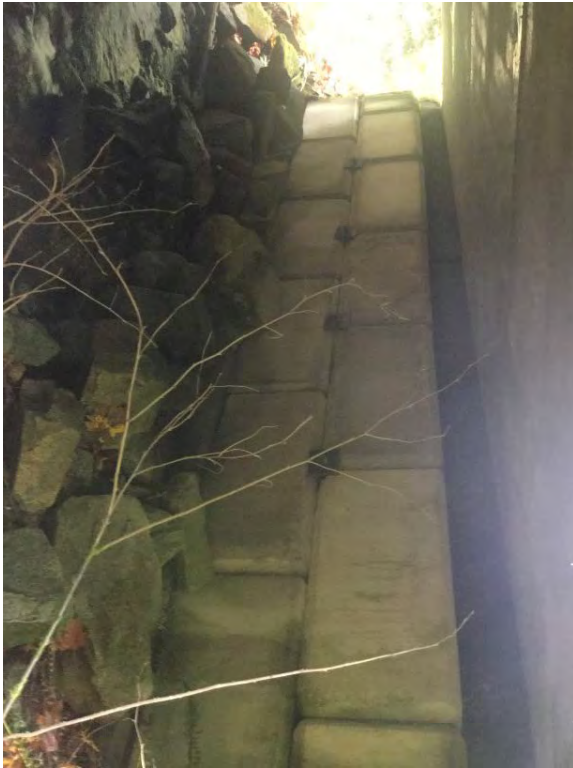
Right Bank Abutment when facing downstream

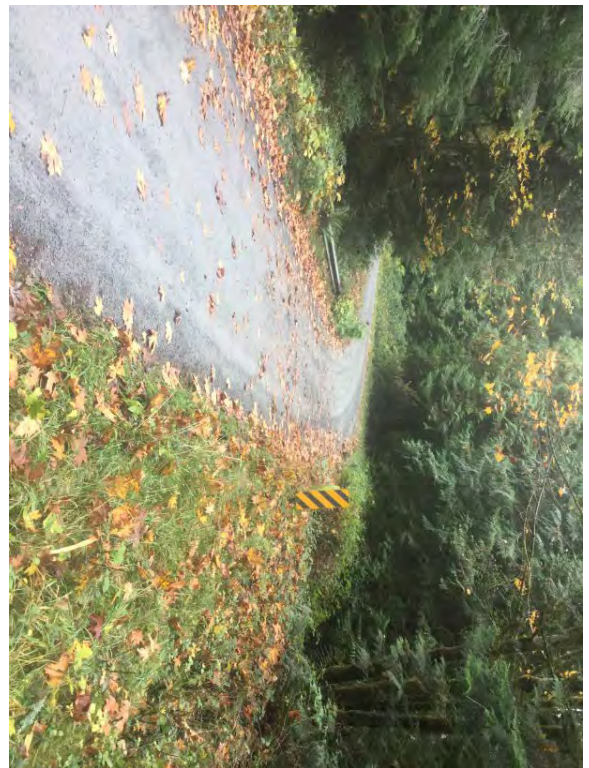
Approach from Right Bank when facing downstream

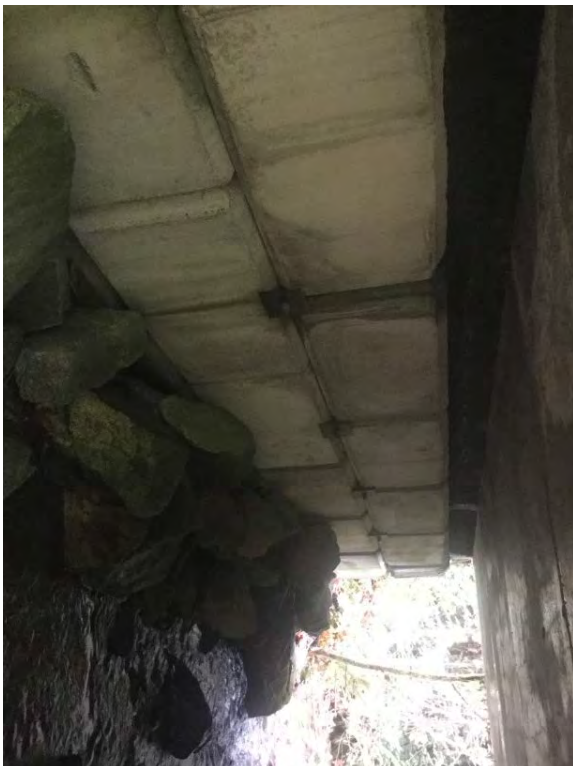
Left Bank Abutment when facing downstream

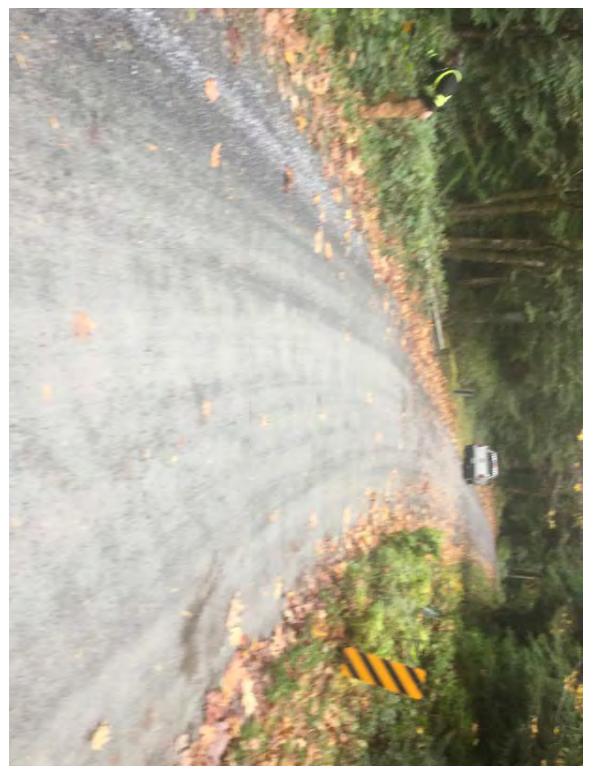
Approach from Left Bank when facing downstream
