SC-8636

MCNAB/POTLATCH 7.03km

2019 Inspection

| Structure Class | Major Culvert |

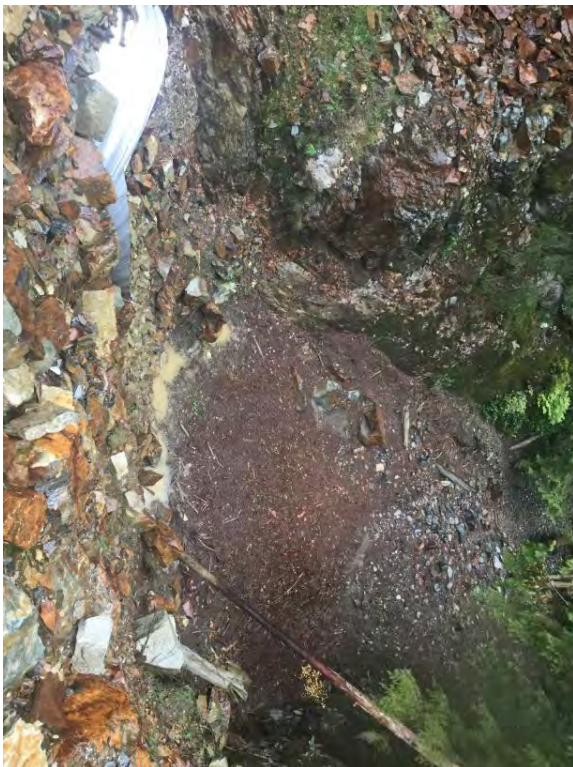
Inlet perched approx 2.5m above streambed. Subsurface flow. Culvert not functioning only acting as overflow pipe. Recommend re install. Need longer pipe to instal deeper.

Inlet Fair Perched 2.5m Above upstream streambed

Load Rated by: Forrest Simpson, EIT, Mar 6, 2020  
Load Rating: L165 or 150 tonnes  
Next Inspection: 2022  
Comments: Plan for removal within three years.
