SC-8637

MCNAB/POTLATCH 7.55km

2019 Inspection

| Structure Class | Major Culvert |

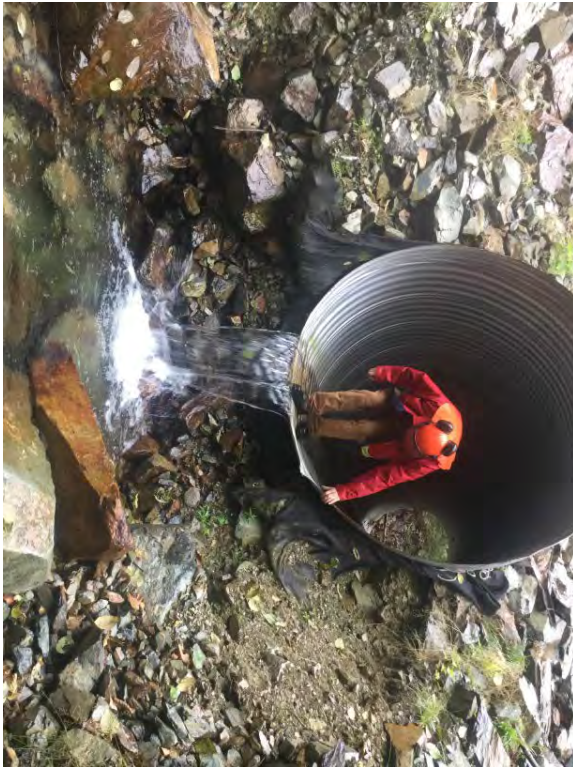
Outlet Poor Outlet plunge pool. In fill with large riprap.

Aggradation ☐Scour ☒

Load Rated by: Forrest Simpson, EIT, Mar 6, 2020  
Load Rating: L165 or 150 tonnes  
Next Inspection: 2022  
Comments: Infill plunge pool at outlet with large riprap.

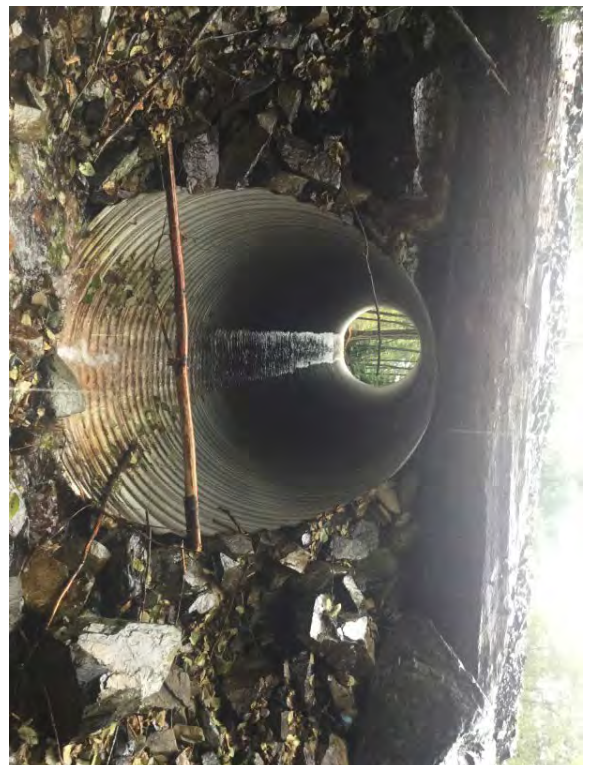
Inlet Good
