SC-8638

2019 Inspection

## Inspection

Date of Inspection 2019-04-11 3:43:35 PM

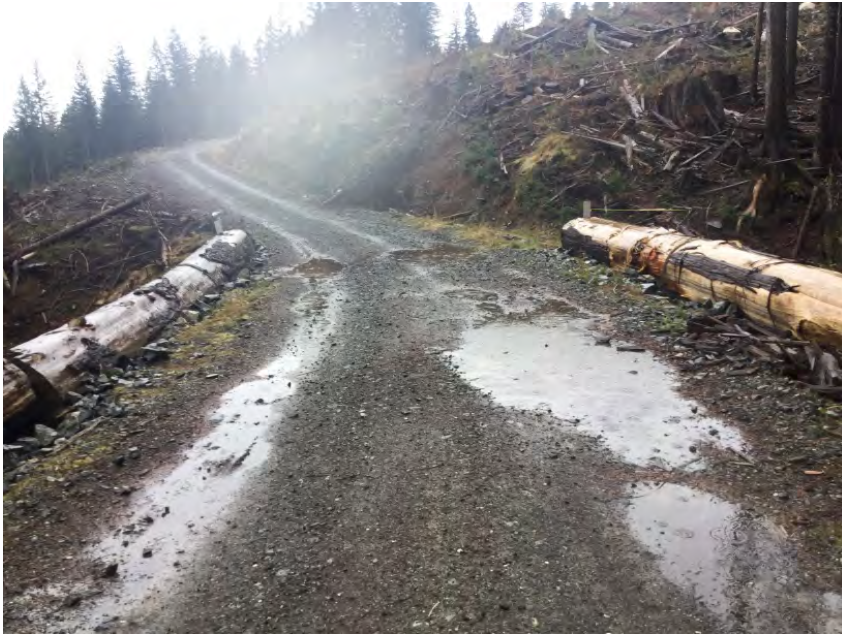
Approach from Left Bank when facing downstream

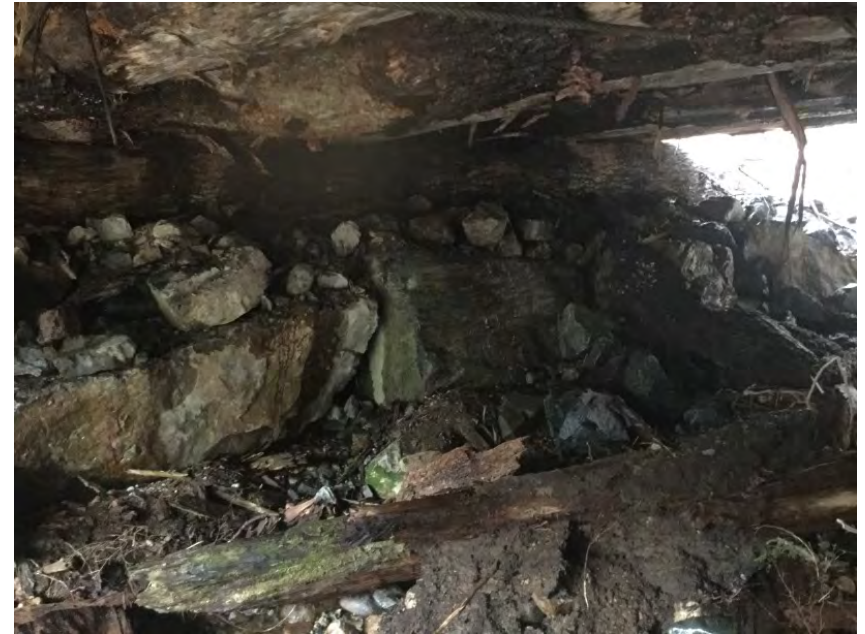
Right Bank Abutment when facing downstream

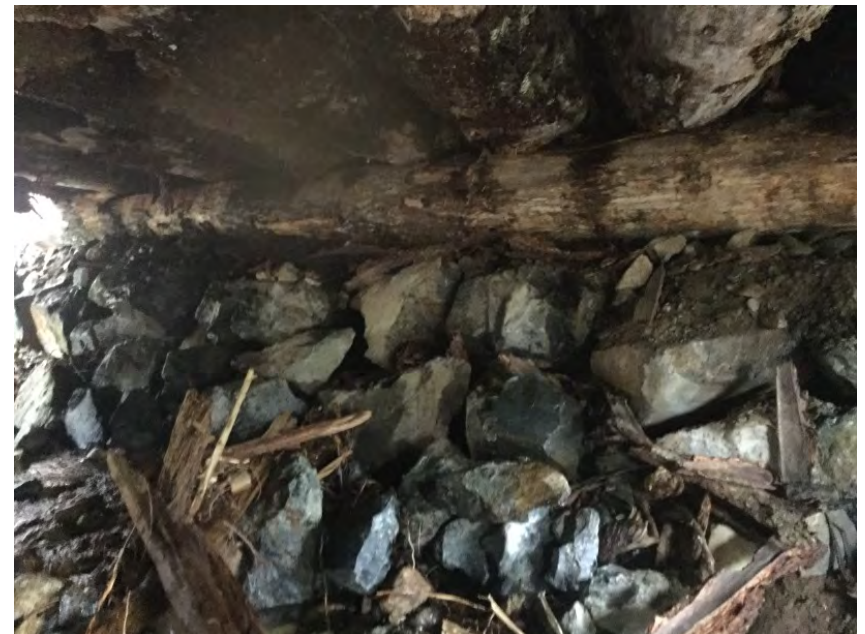
Left Bank Abutment when facing downstream
