SC-8639

2019 Inspection

CBR iPad Offline Ver 0.26

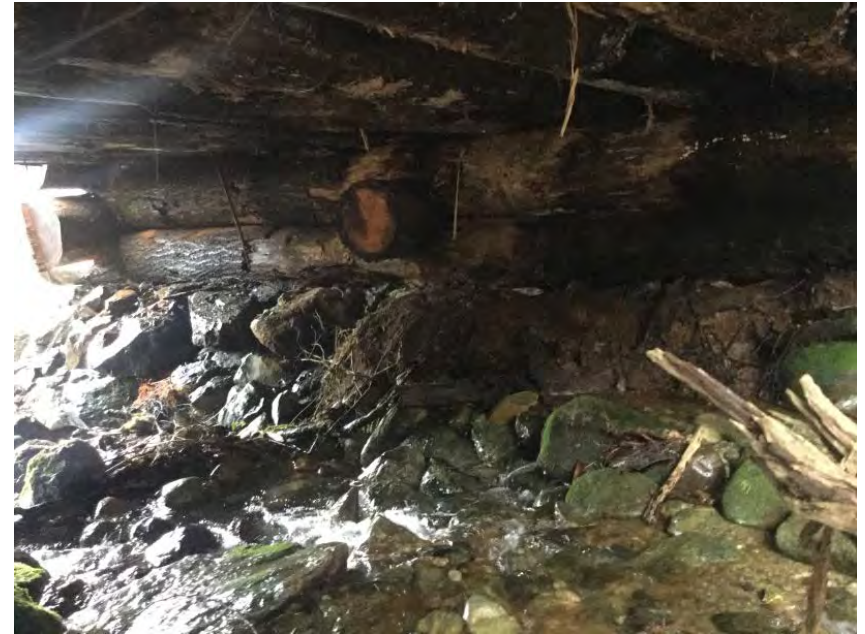
Right Bank Abutment when facing downstream

Riprap Fair Ds right undermined. Monitor

| Item | Monitor Description | Frequency |
|---|---|---|
| 1 | Monitor ds right abutment crb | Routine Inspection |
