SC-8001

CLOWHOM 7.1km

2020 Inspection

| Crossing Name | Bear Creek | | |

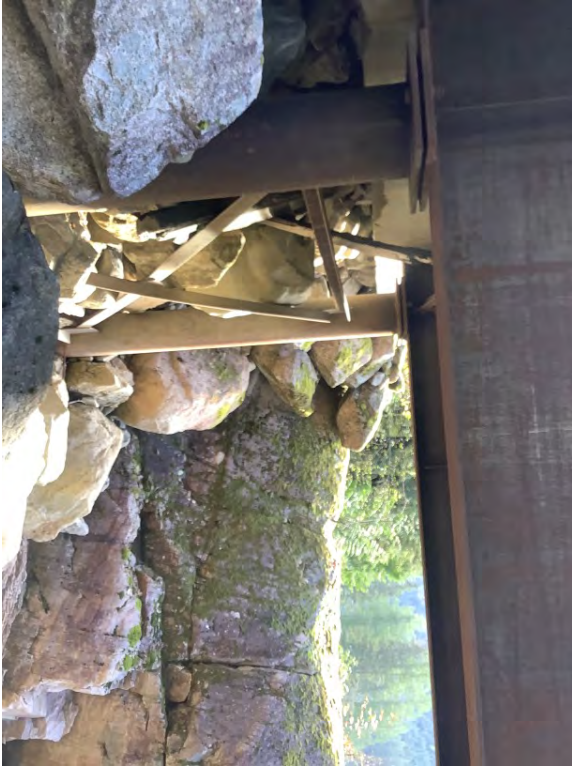
Left Bank Abutment when facing downstream

Bent slightly on left side. No change since last inspection

Missing / oversteepened on left side.

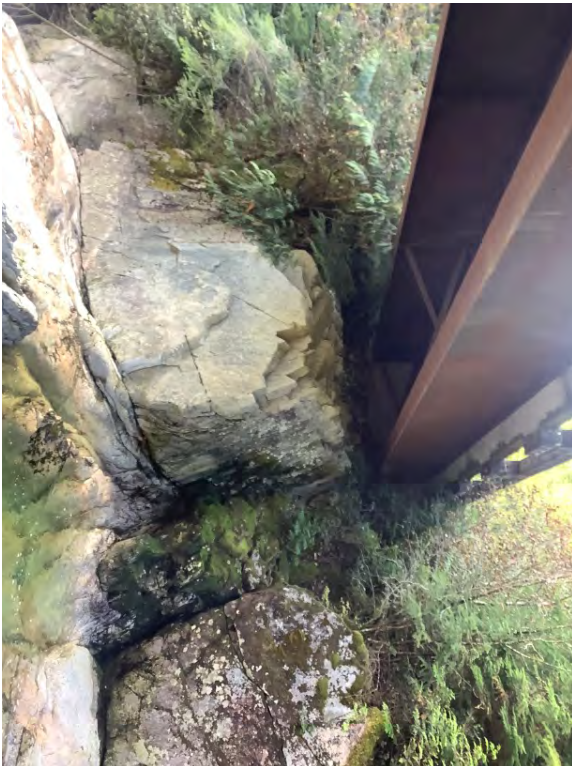
Right Bank Abutment when facing downstream

Bolts on right bent towards right side. No apparent change since last inspection for both sides.

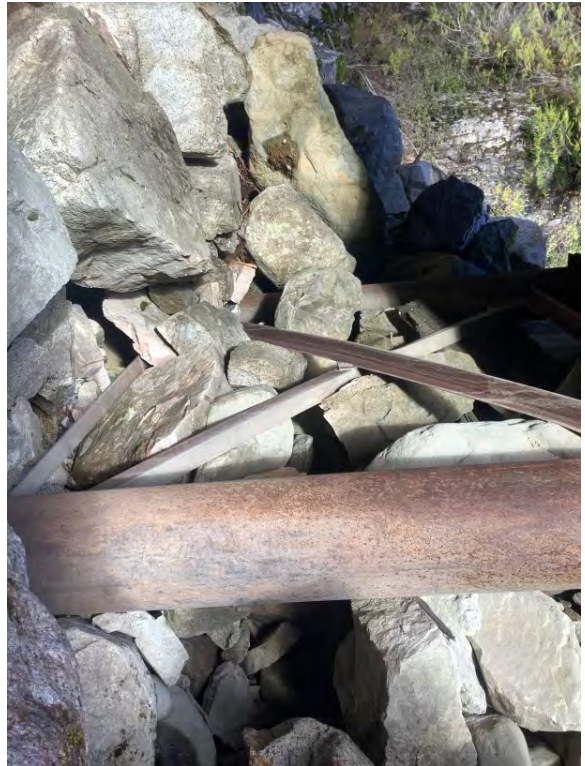
Upstream Profile

Both girders bowed towards downstream side. Rust scale behind right abutment, upstream and downstream sides. Scale on some joints., top flange. No apparent change since last

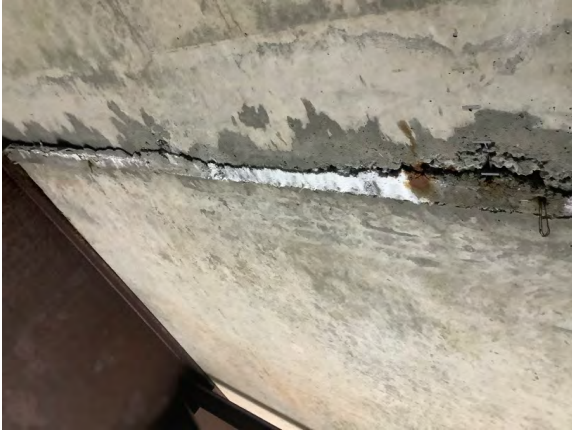
Deck Joints      Fair      Grout not flush with deck surface. Fair to poor grout.

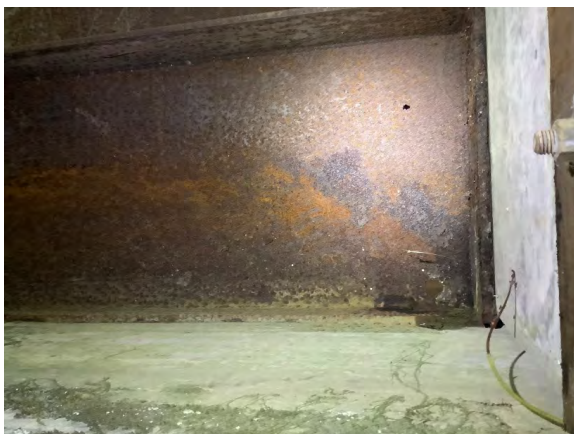
Upstream Profile - right side; rust scale

| Item | Monitor Description | Frequency |
|---|---|---|
| 1 | Monitor corrosion, abutment, bolts, girders, deck joints. | Routine Inspection |
