SC-8021

EAST WILSON 1.7km

2020 Inspection

| Crossing Name | Lower East Wilson Creek |

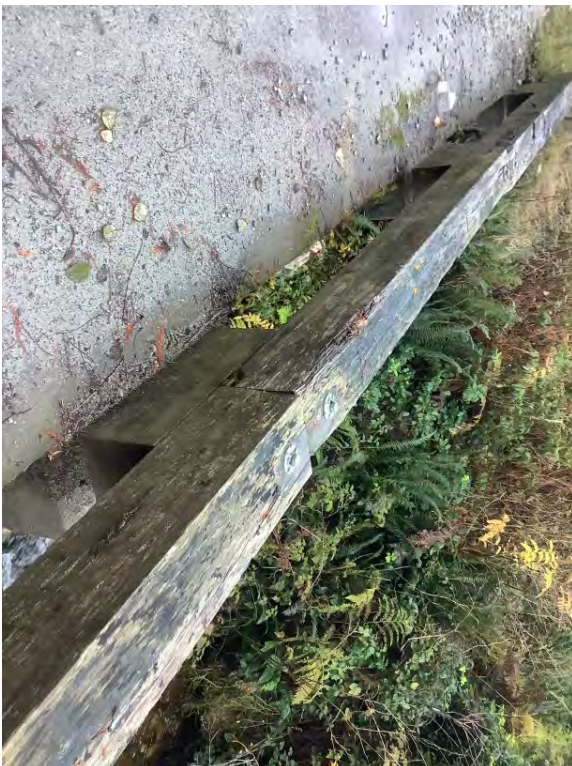
Guard Rail

Curb Rail/Blocks/Posts      **Fair**      Replace within 3 years

Load Rated by: Richard Mills, P.Eng. Feb 2, 2021  
Load Rating: L75 or 68 tonnes  
Next Inspection: 2023  
Comments: Replace guardrails within 3 years.

| Repair Item | Priority | Repair Description |
|---|---|---|
| 1 | Medium | Replace guardrails within 3 years |
