SC-8031

HALFMOON CARLSON 0.8km

2020 Inspection

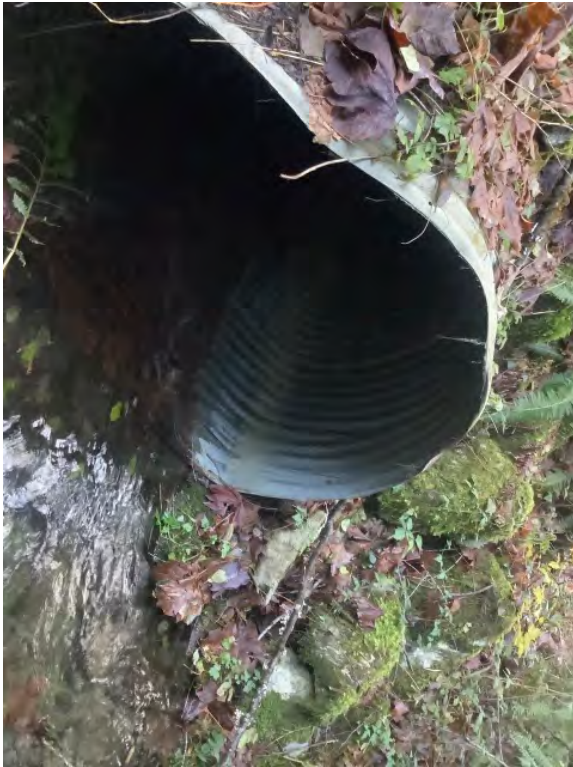
| Inlet | Good | |

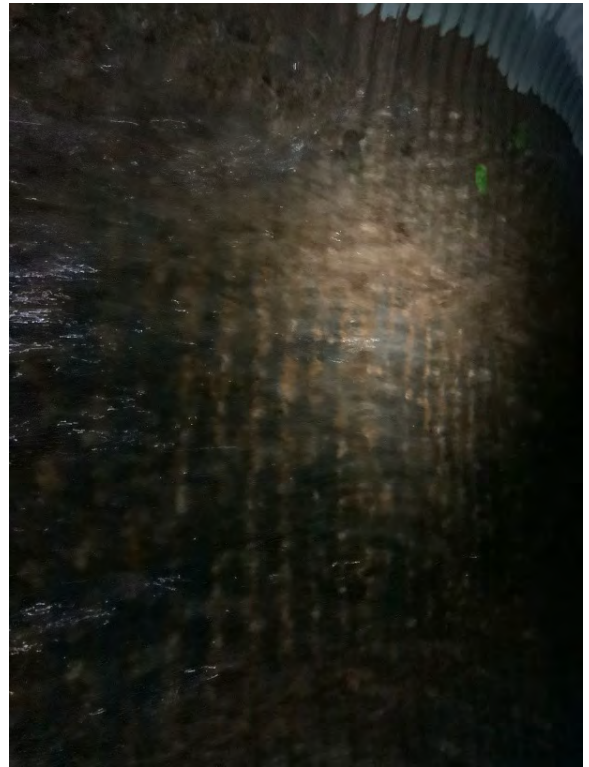
| Floor | Fair | Minor corrosion |

| Item | Monitor Description | Frequency |
|---|---|---|
| 1 | Monitor corrosion on floor | Routine Inspection |
