SC-8032

HALFMOON CARLSON 0.5km

2020 Inspection

| Structure Class | Major Culvert |

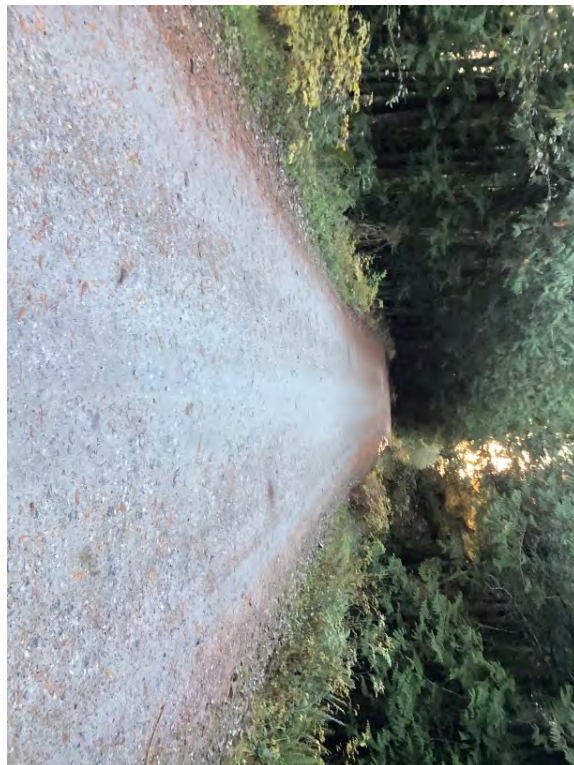
Approach from Left Bank when facing downstream

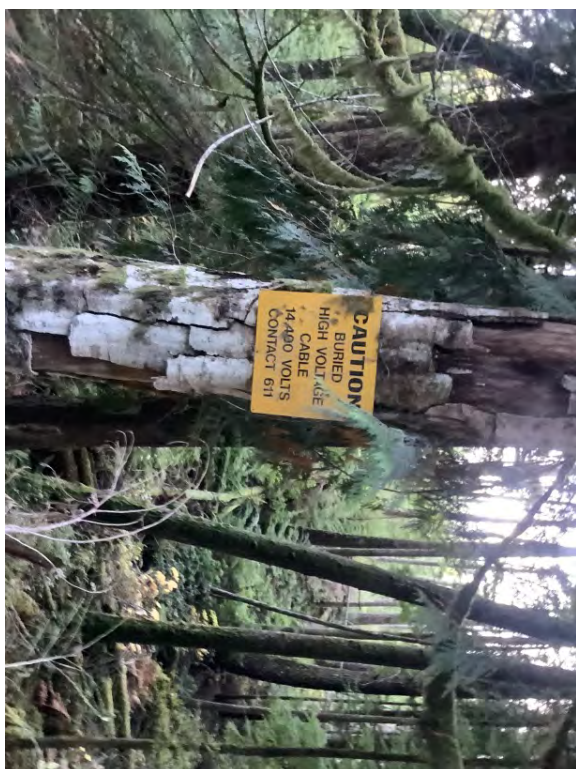
High voltage cable nearby
