SC-8052

MCNAIR 0.2km

2020 Inspection

| Crossing Name | Mohawk Creek |

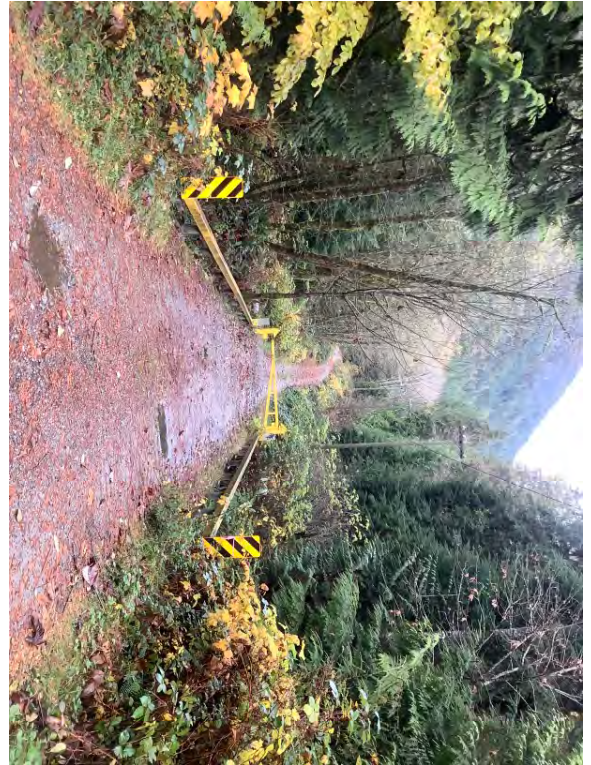
Unable to access, behind locked gate.

Load Rated by: Richard Mills, P.Eng. Feb 18, 2021  
Load Rating: TBD  
Next Inspection: 2021  
Comments: Gate key required for access.
