SC-8055

MCNAB 7.85km

2020 Inspection

| Crossing Name | Cascara Creek |

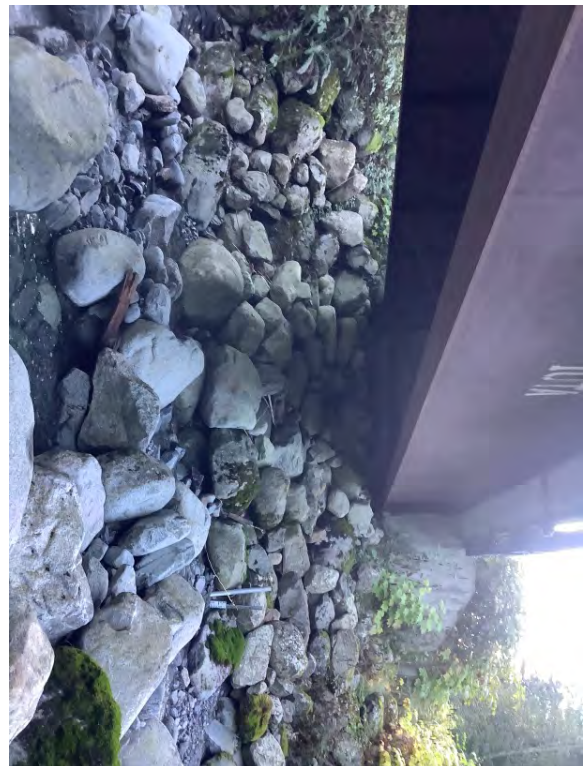
Right Bank Abutment when facing downstream

Riprap Fair Slight undermining right side. Subangular riprap

| Item | Monitor Description | Frequency |
|---|---|---|
| 1 | Monitor riprap for scour | Routine Inspection |
