SC-8056

MCNAB/POTLATCH 0.48km

2020 Inspection

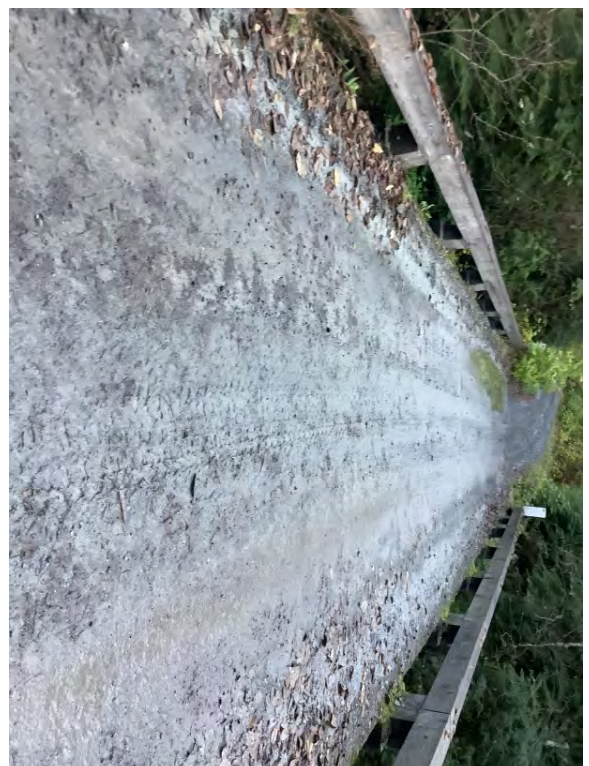
Deck

Curb Rail/Blocks/Posts      Fair      Replace in 3 years

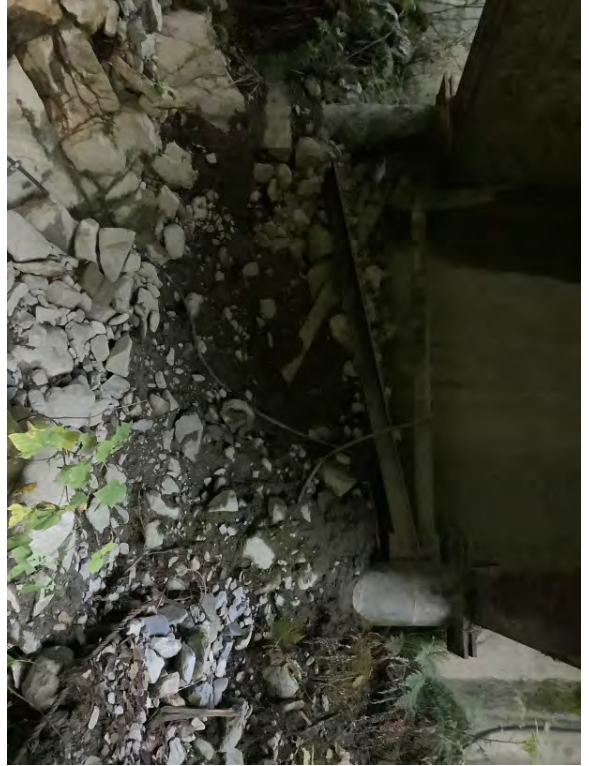
Left Bank Abutment when facing downstream

Check footing type to see if cast in place footings on left side. Otherwise there is scour potential, may require riprap. Guardrail, fair, will require replacement in 3 years.

Riprap N/A No riprap left side. Check that footings are cast in place. Scoured.
