SC-8075

MISERY CREEK 6.3km

2020 Inspection

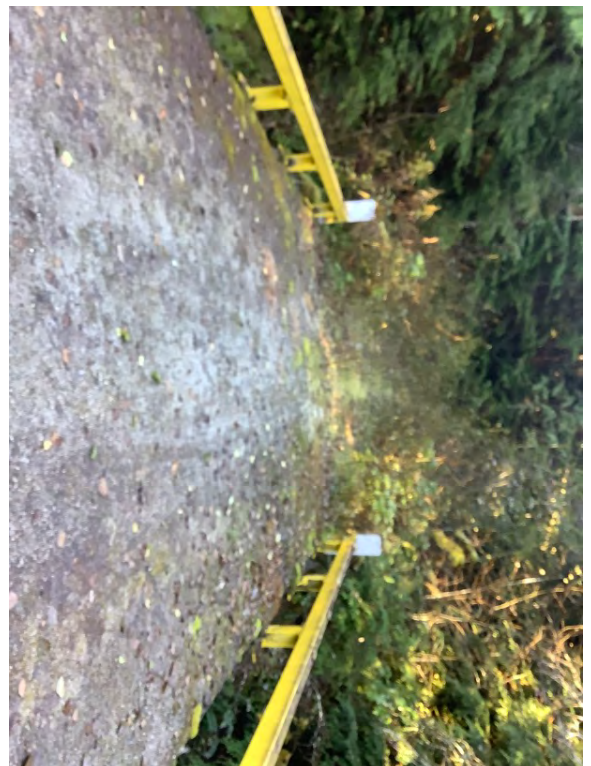
Deck Joints Poor Water running onto girders from deck joints.

| 1 | Low | Remove gravel from deck |

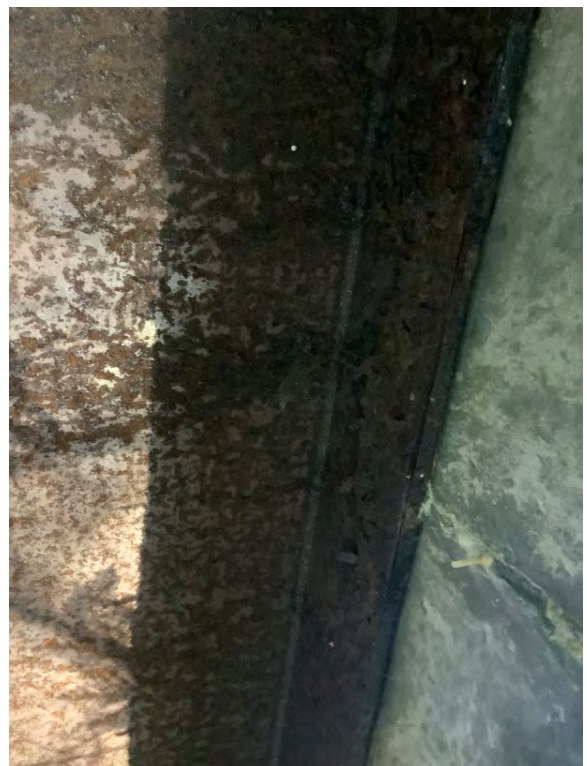
Rust scale on girders. Does not appear to have changed much from last inspection. Mainly confined to upper flange, near deck joints. Monitor. Road becoming grown in.

Girders Fair Rust scale

Rust scale - top flange DS side

| Item | Monitor Description | Frequency |
|---|---|---|
| 1 | Monitor rust scale | Routine Inspection |
