SC-8113

ROBERTS FLUME 0.7km

2020 Inspection

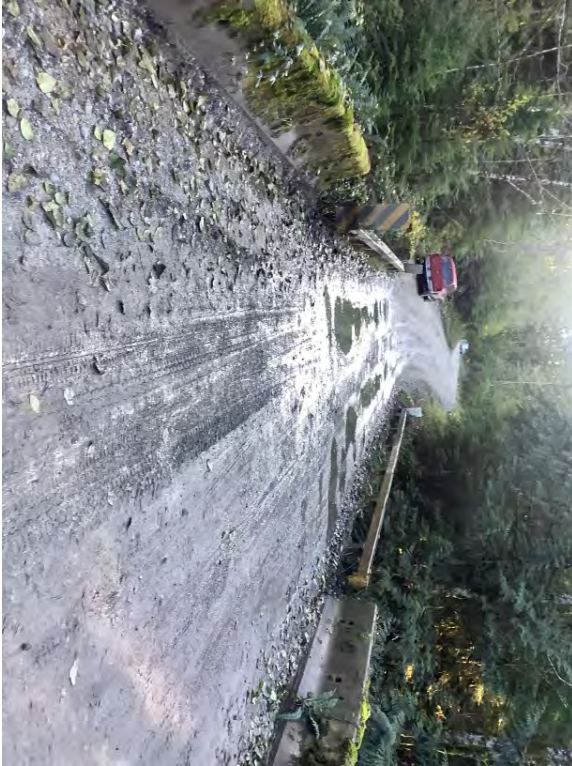
Approach from Right Bank when facing downstream

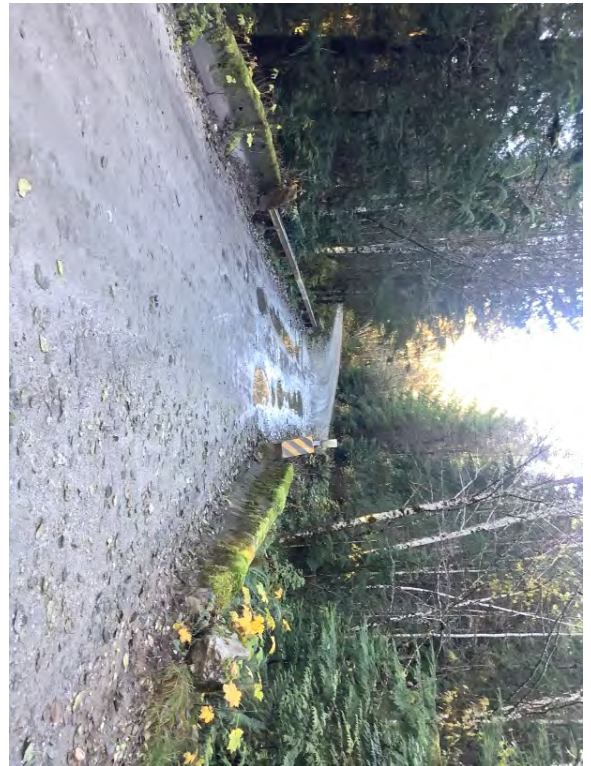
Approach from Right Bank when facing downstream

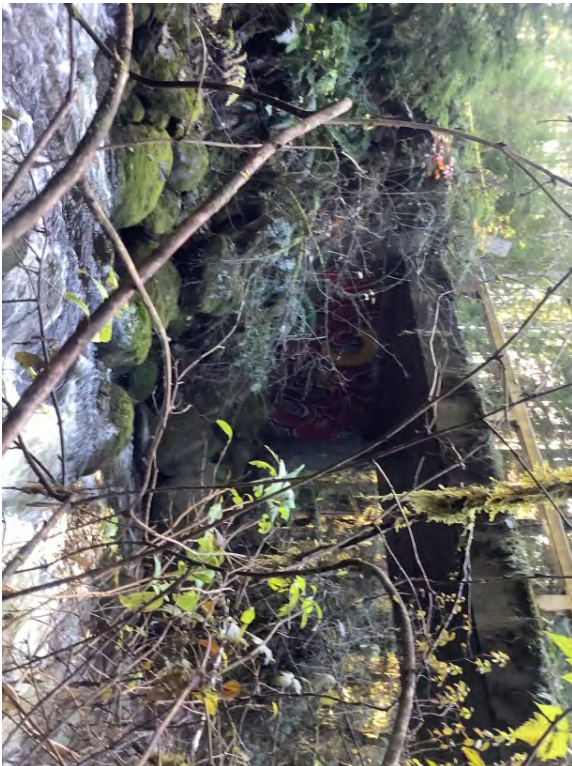
Left Bank Abutment when facing downstream

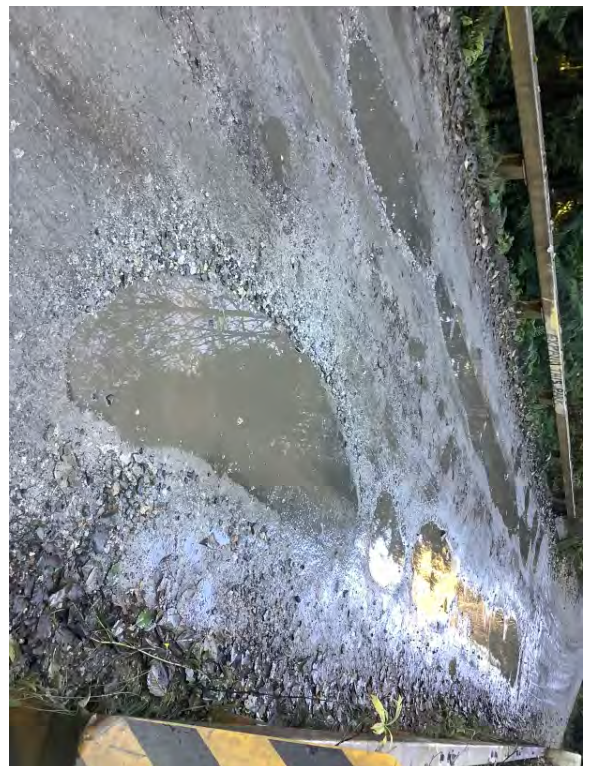
Deck

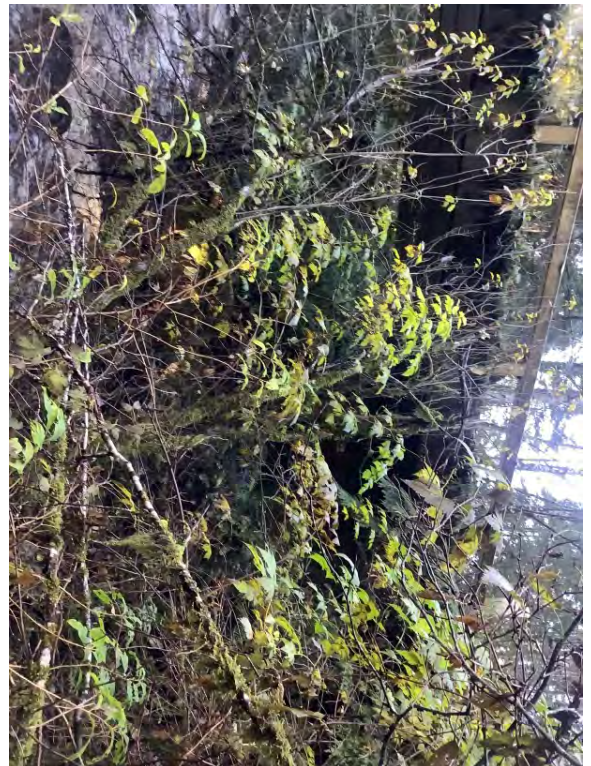
Right Bank Abutment when facing downstream

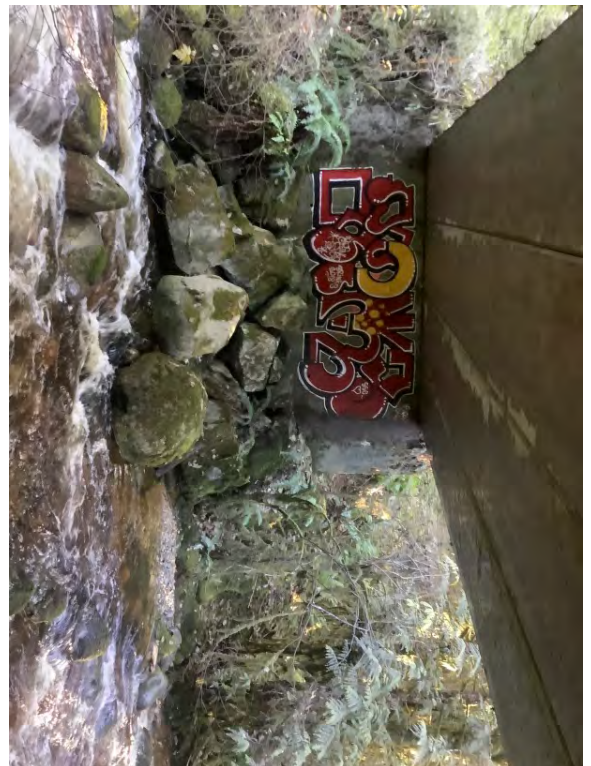
Right Bank Abutment when facing downstream
