SC-8142

SECHELT DAKOTA 27.1km

2020 Inspection

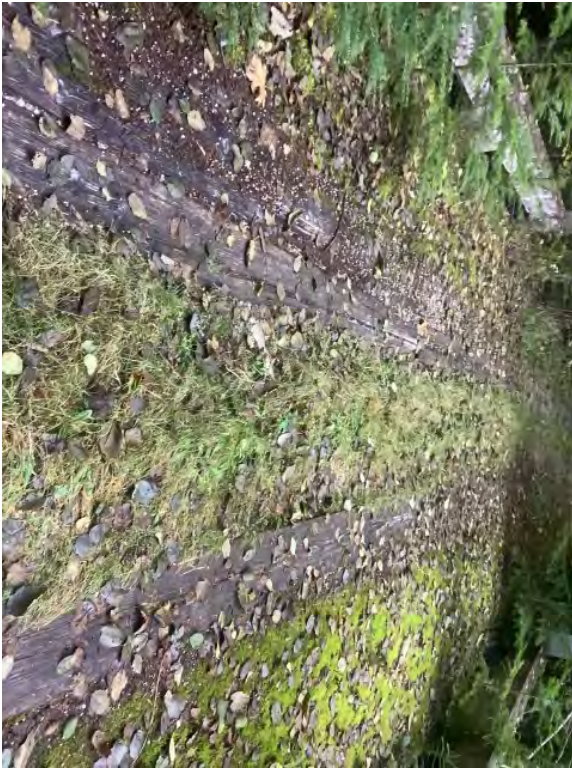
| Running Planks | Poor | Rotten |
| Ties | Poor | Rotten |
| Overall Deck Condition | Poor | Due to timber condition |

| Repair Item | Priority | Repair Description |
|---|---|---|
| 1 | Medium | Replace timber deck and guardrails |

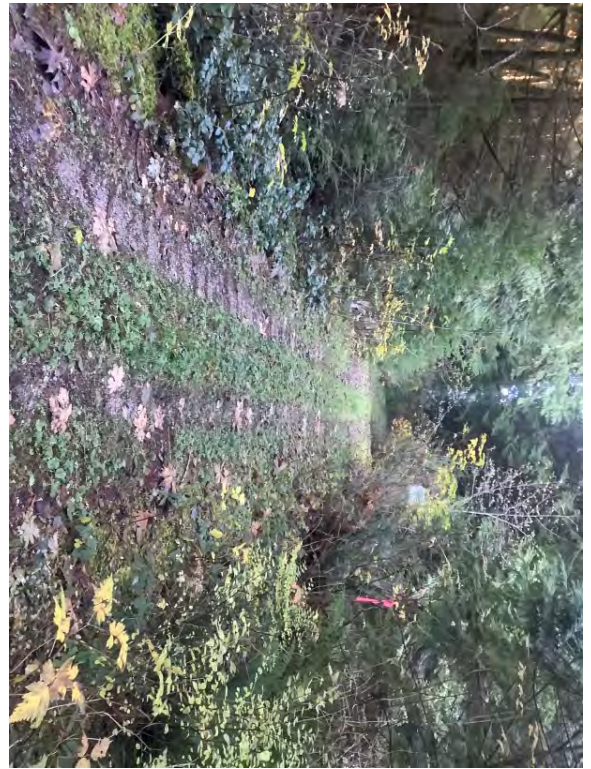
Approach from Right Bank when facing downstream

Road Surface Poor Partial deactivated. 4x4 access only.

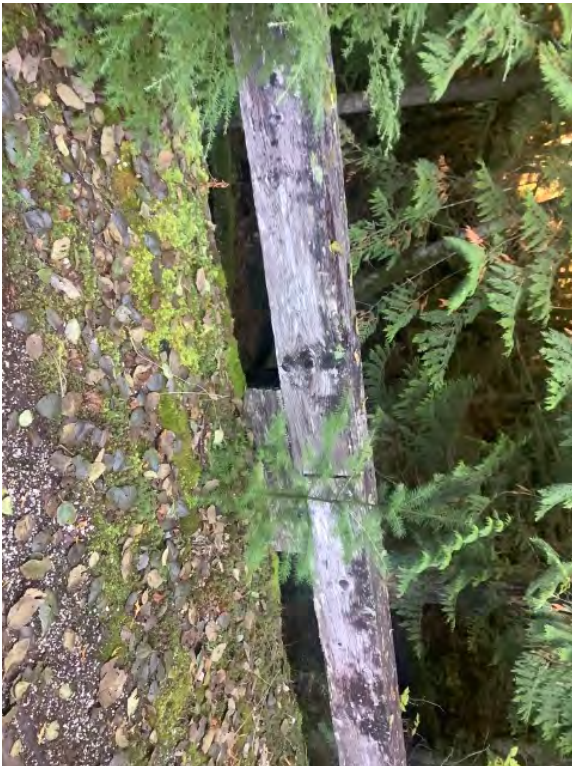
Guard Rail

| Curb Rail/Blocks/Posts | Poor | Rotten |

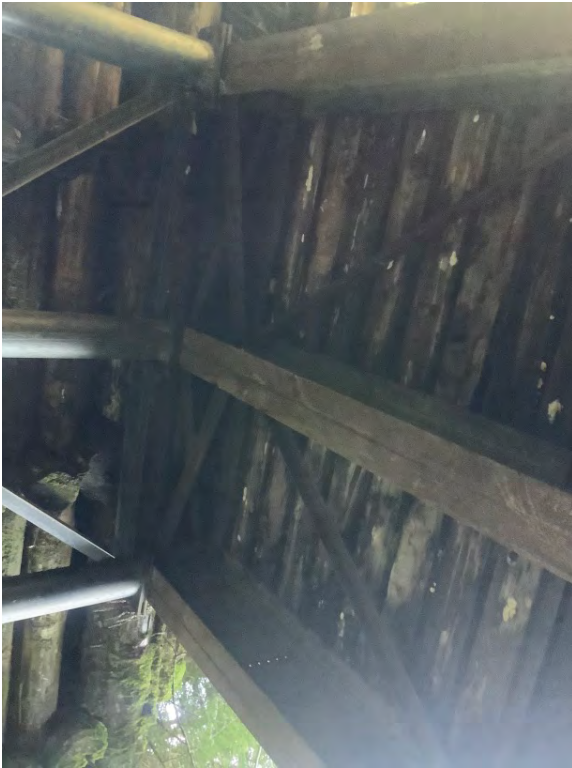
Superstructure

3 girders. Re-used girders.
