SC-8144

SECHELT DAKOTA 35.8km

2020 Inspection

| Structure Class | Major Culvert |

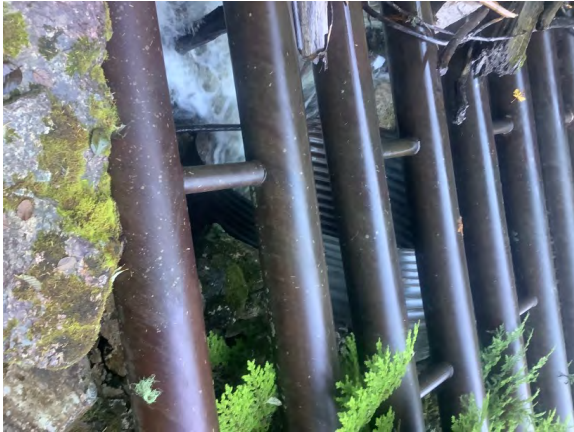
| Inlet | Fair | Debris on trash rack |
| Trash Rack | Fair | Debris and boulders on top |

| Item | Priority | Repair Description |
|---|---|---|
| 1 | Low | Remove debris / boulders from trash rack |

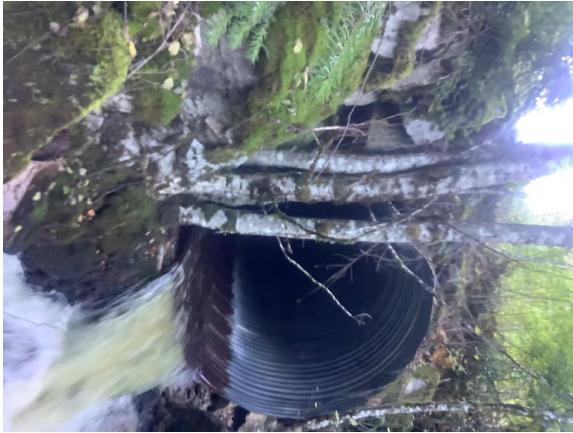
| Outlet | Good | |
| Rip Rap | Fair | |

| Item | Monitor Description | Frequency |
|---|---|---|
| 1 | Monitor downstream riprap | Routine Inspection |
