SC-8301

LOIS 9.22km

2020 Inspection

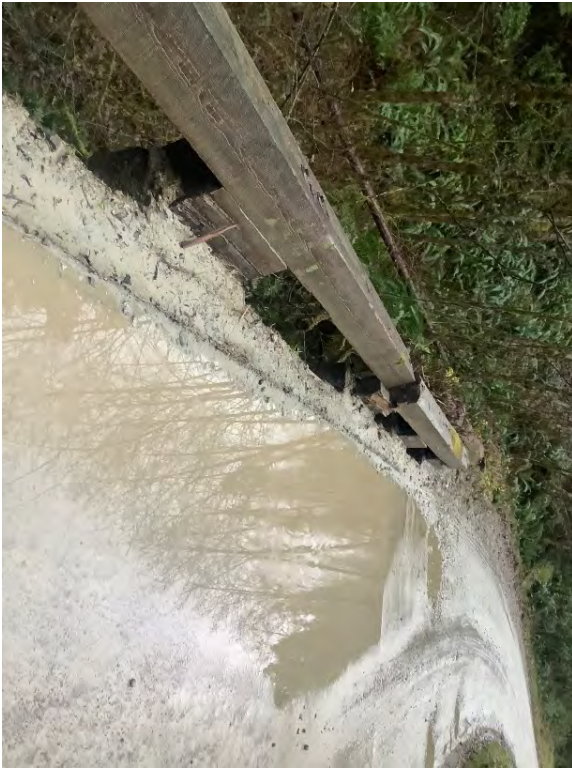
Guard Rail

Curb Rail/Blocks/Posts      Poor      Rotten, broken.

| 1 | High | Replace guardrails |

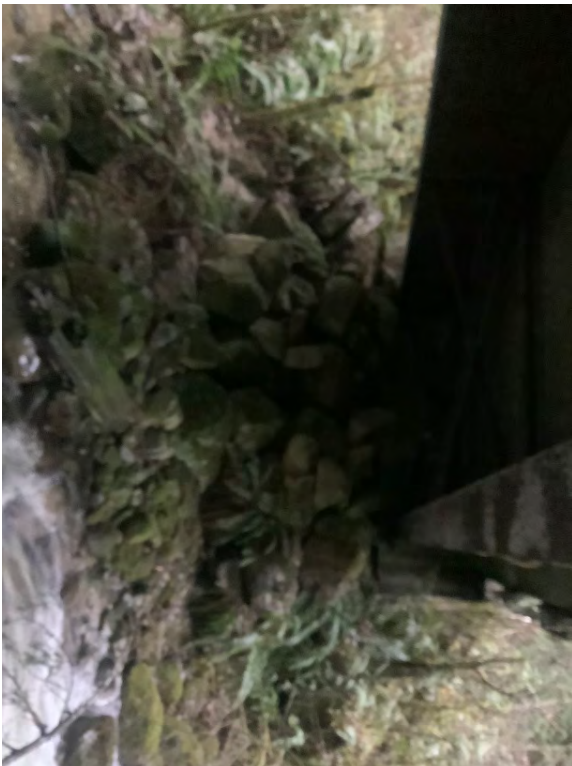
Right Bank Abutment when facing downstream

Riprap Fair Steep, but effective
