SC-8302

LOIS 10.85km

2020 Inspection

CBR iPad Offline Ver 0.31

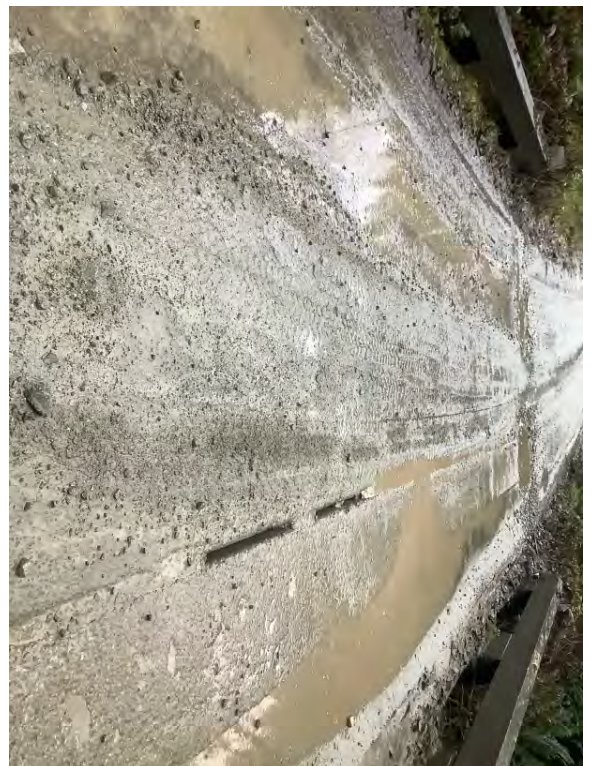
Deck Joints Poor Mud getting into creek below.

Load Rated by: Richard Mills, P.Eng. March 3, 2021  
Load Rating: L165 or 150 tonnes  
Next Inspection: 2021  
Comments: Consider adding paraseal to deck joints.

| Item | Priority | Repair Description |
|---|---|---|
| 1 | Low | Paraseal deck joints to stop mud from entering stream |

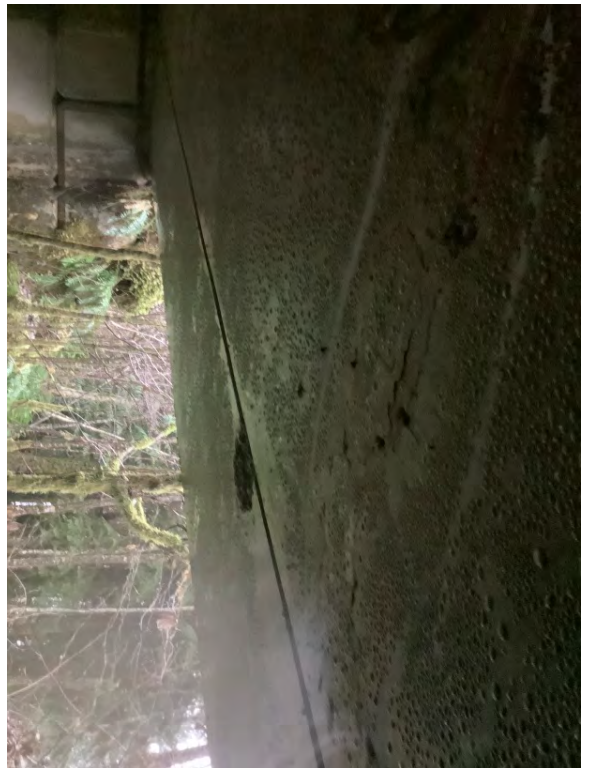
Repaired section, minor chip DS right side

Superstructure-repaired area, minor chip DS right side
