SC-8354

SECHELT GRAY 0.2km

2020 Inspection

| Road Name | SECHELT GRAY |

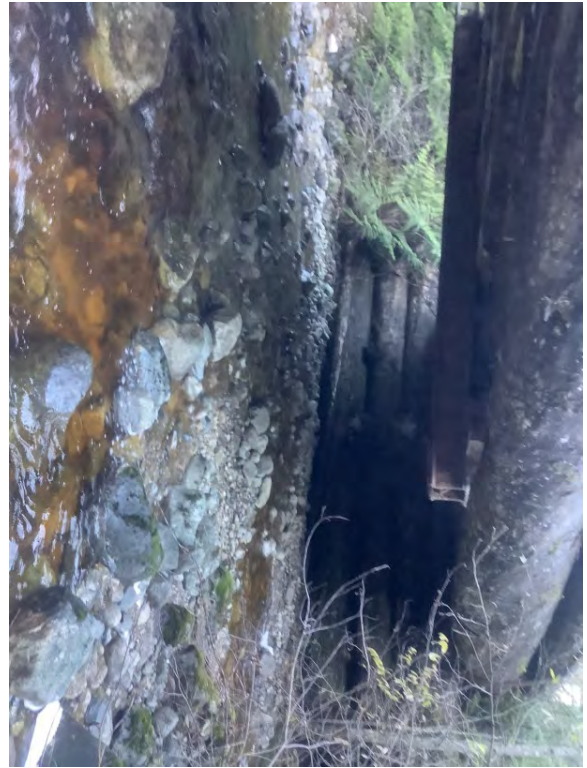
Right Bank Abutment when facing downstream

Log/Timber Cribbs Poor Rotten, undermined

Tie Backs Poor Rotten

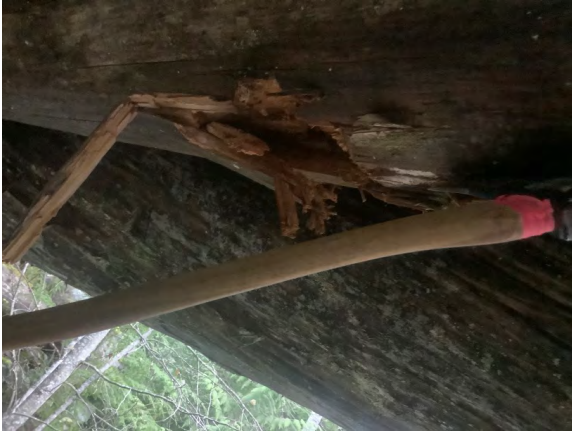
Stringers

Rotten stringers. 150mm sap rot overall.

| 1 | Medium | Plan to replace or deactivate |
