SC-8358

SECHELT CREEK 8.03km

2020 Inspection

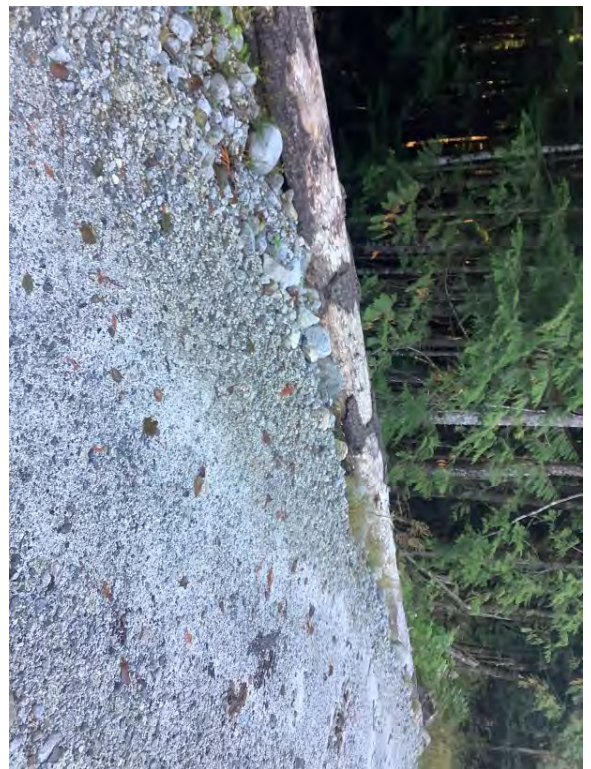
Guard Rail

Too low DS side

| 2 | High | Guardrail inadequate DS side |

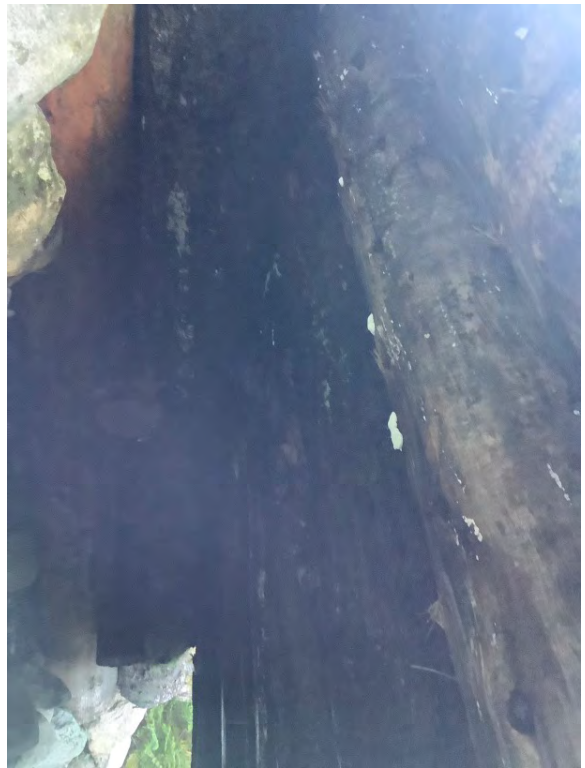
Stringers have conk

Comments Stringers have conk. 50mm ave sap rot. Replace prior to industrial use.

| 1 | High | Replace prior to industrial use |
